Deicing Technology
P.O. Box B
Lansing, NY 14882

RE: Annual Report for Mine File #709-3-29-0052; Cayuga Salt Mine
Permit ID#0-9999-00075-00001
Towns of Lansing and Ulysses, County of Tompkins
Town of Covert, County of Seneca

Annual Reporting, Monitoring, and Notifications

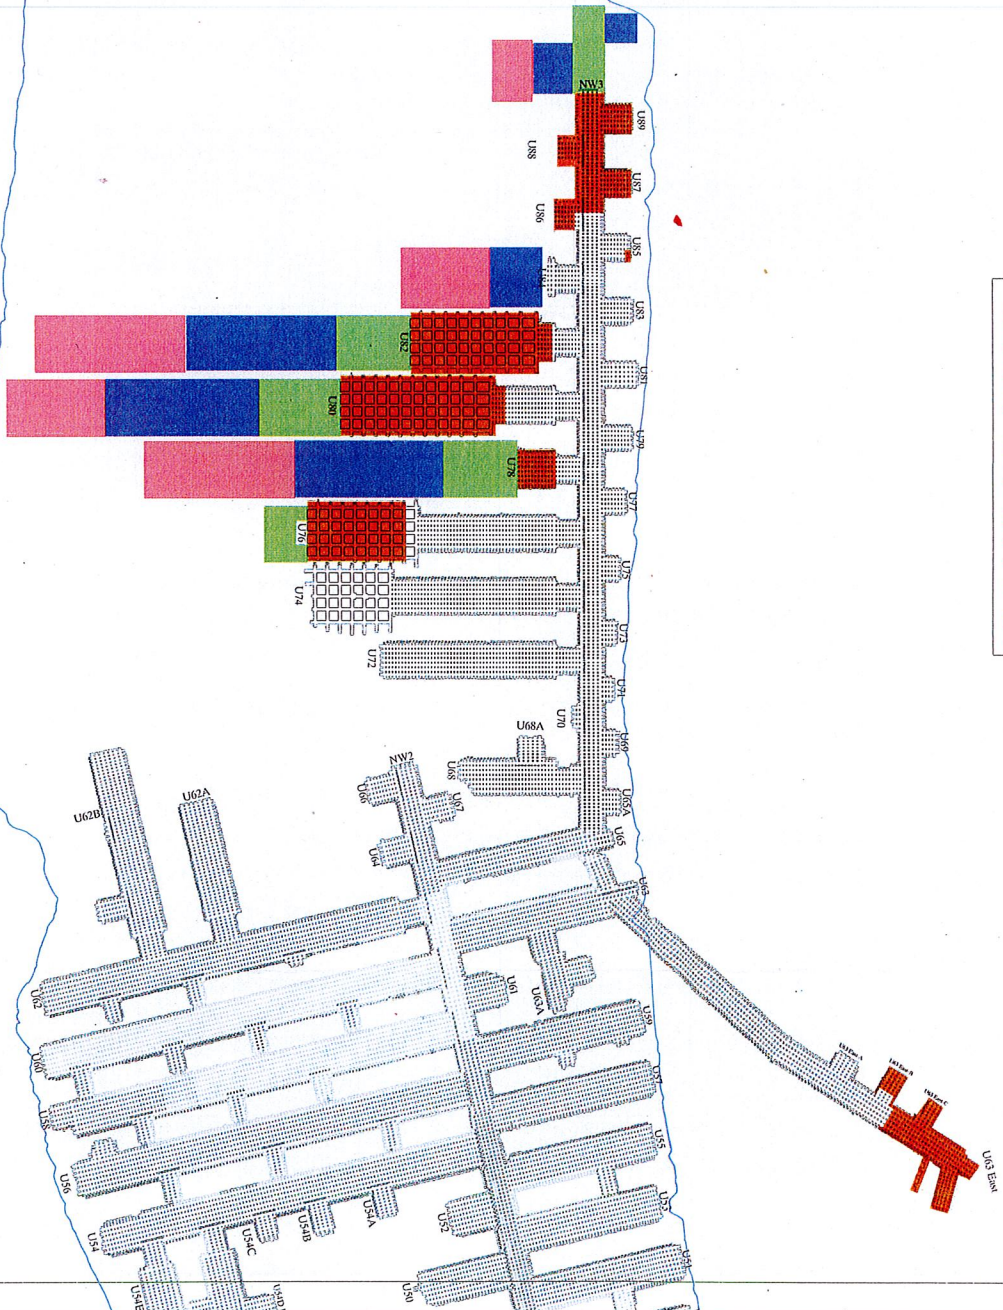
CAYUGA MINE 3-YR MINE PLAN

A map is attached depicting the current and proposed mining for the next three years.

The Cayuga Mine is currently operating in the northern region of the mine. Active mining is located in panels U-76, U-78, U-80, U-82 to the southwest, and NW-3 to the northwest.
