## Annual Reporting, Monitoring, and Notifications

### 12.a.(1) - Cargill Cayuga Mine Manager Certification:

# 2015 DEC Report Outfall Results (Nov 2014 through Oct 2015)

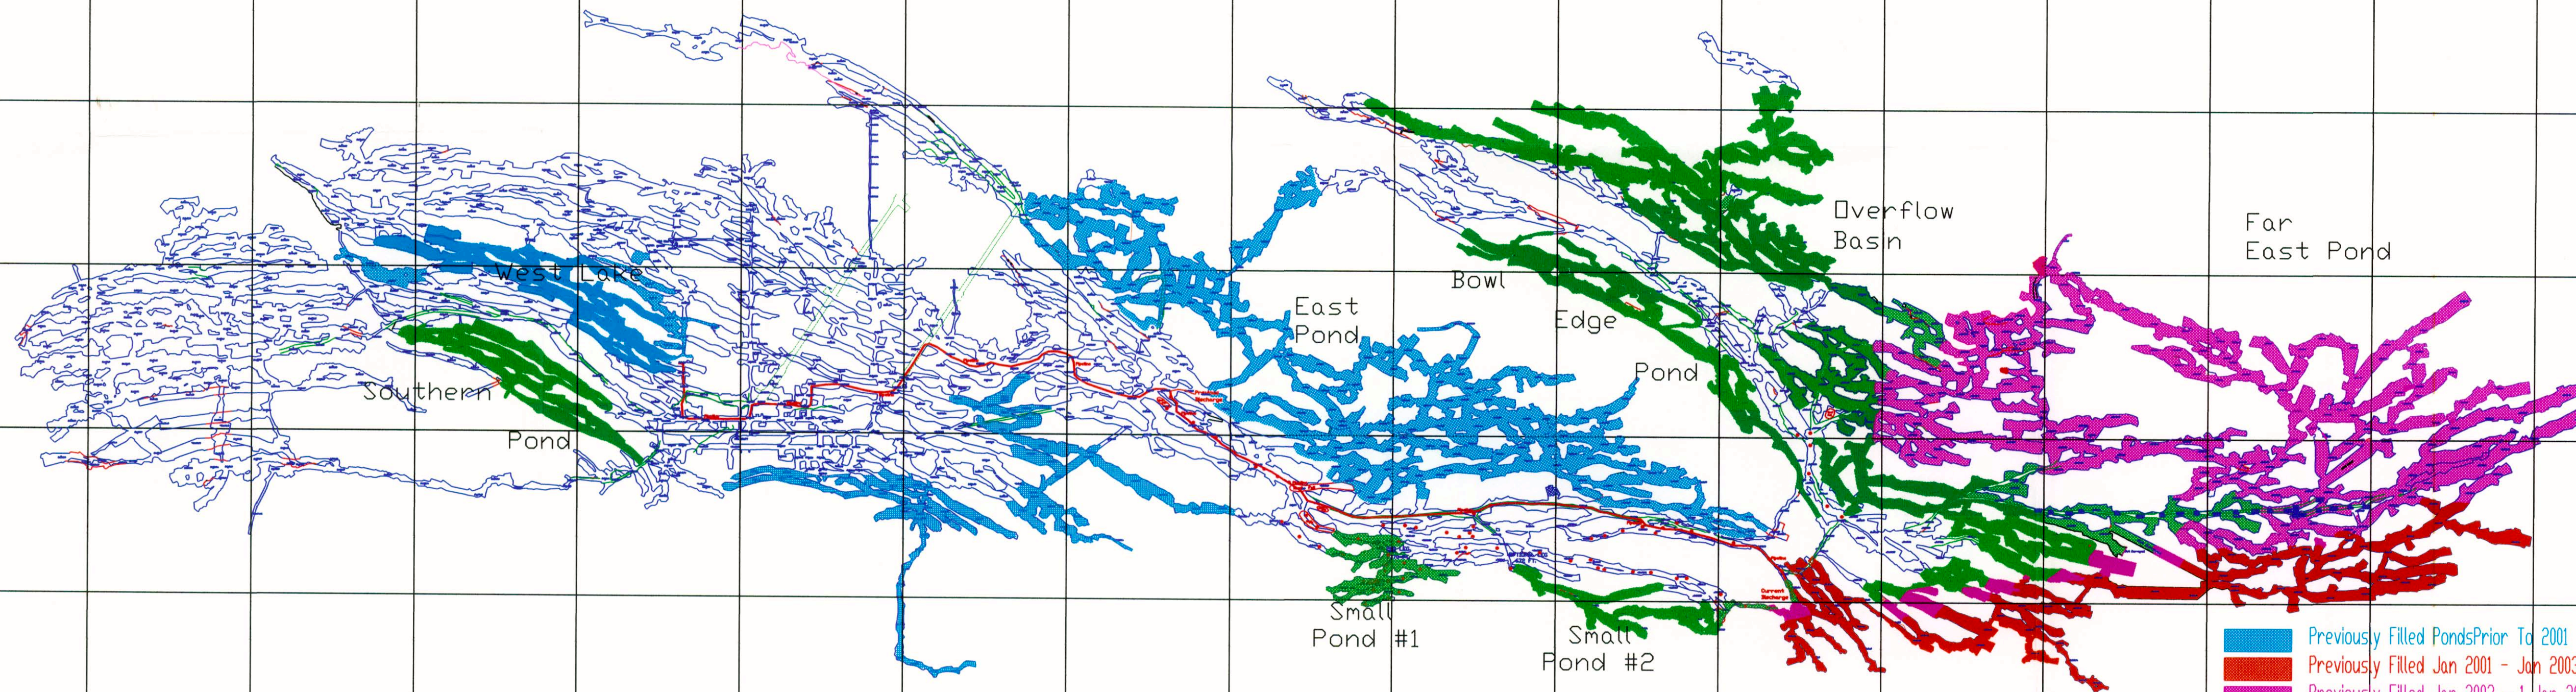
## 4 Level Pond Map

All of the water is directed to a settling pond located on the 4-level of the mine. The water is then pumped from the settling pond to abandoned areas at the far east end of 4-level as well as to various areas of the active mine for dust control. Recent volume calculations indicated that at our current rate of storage (about 18,000,000 gallons per year) we have approximately 6.5 years of storage life remaining on 4-level.

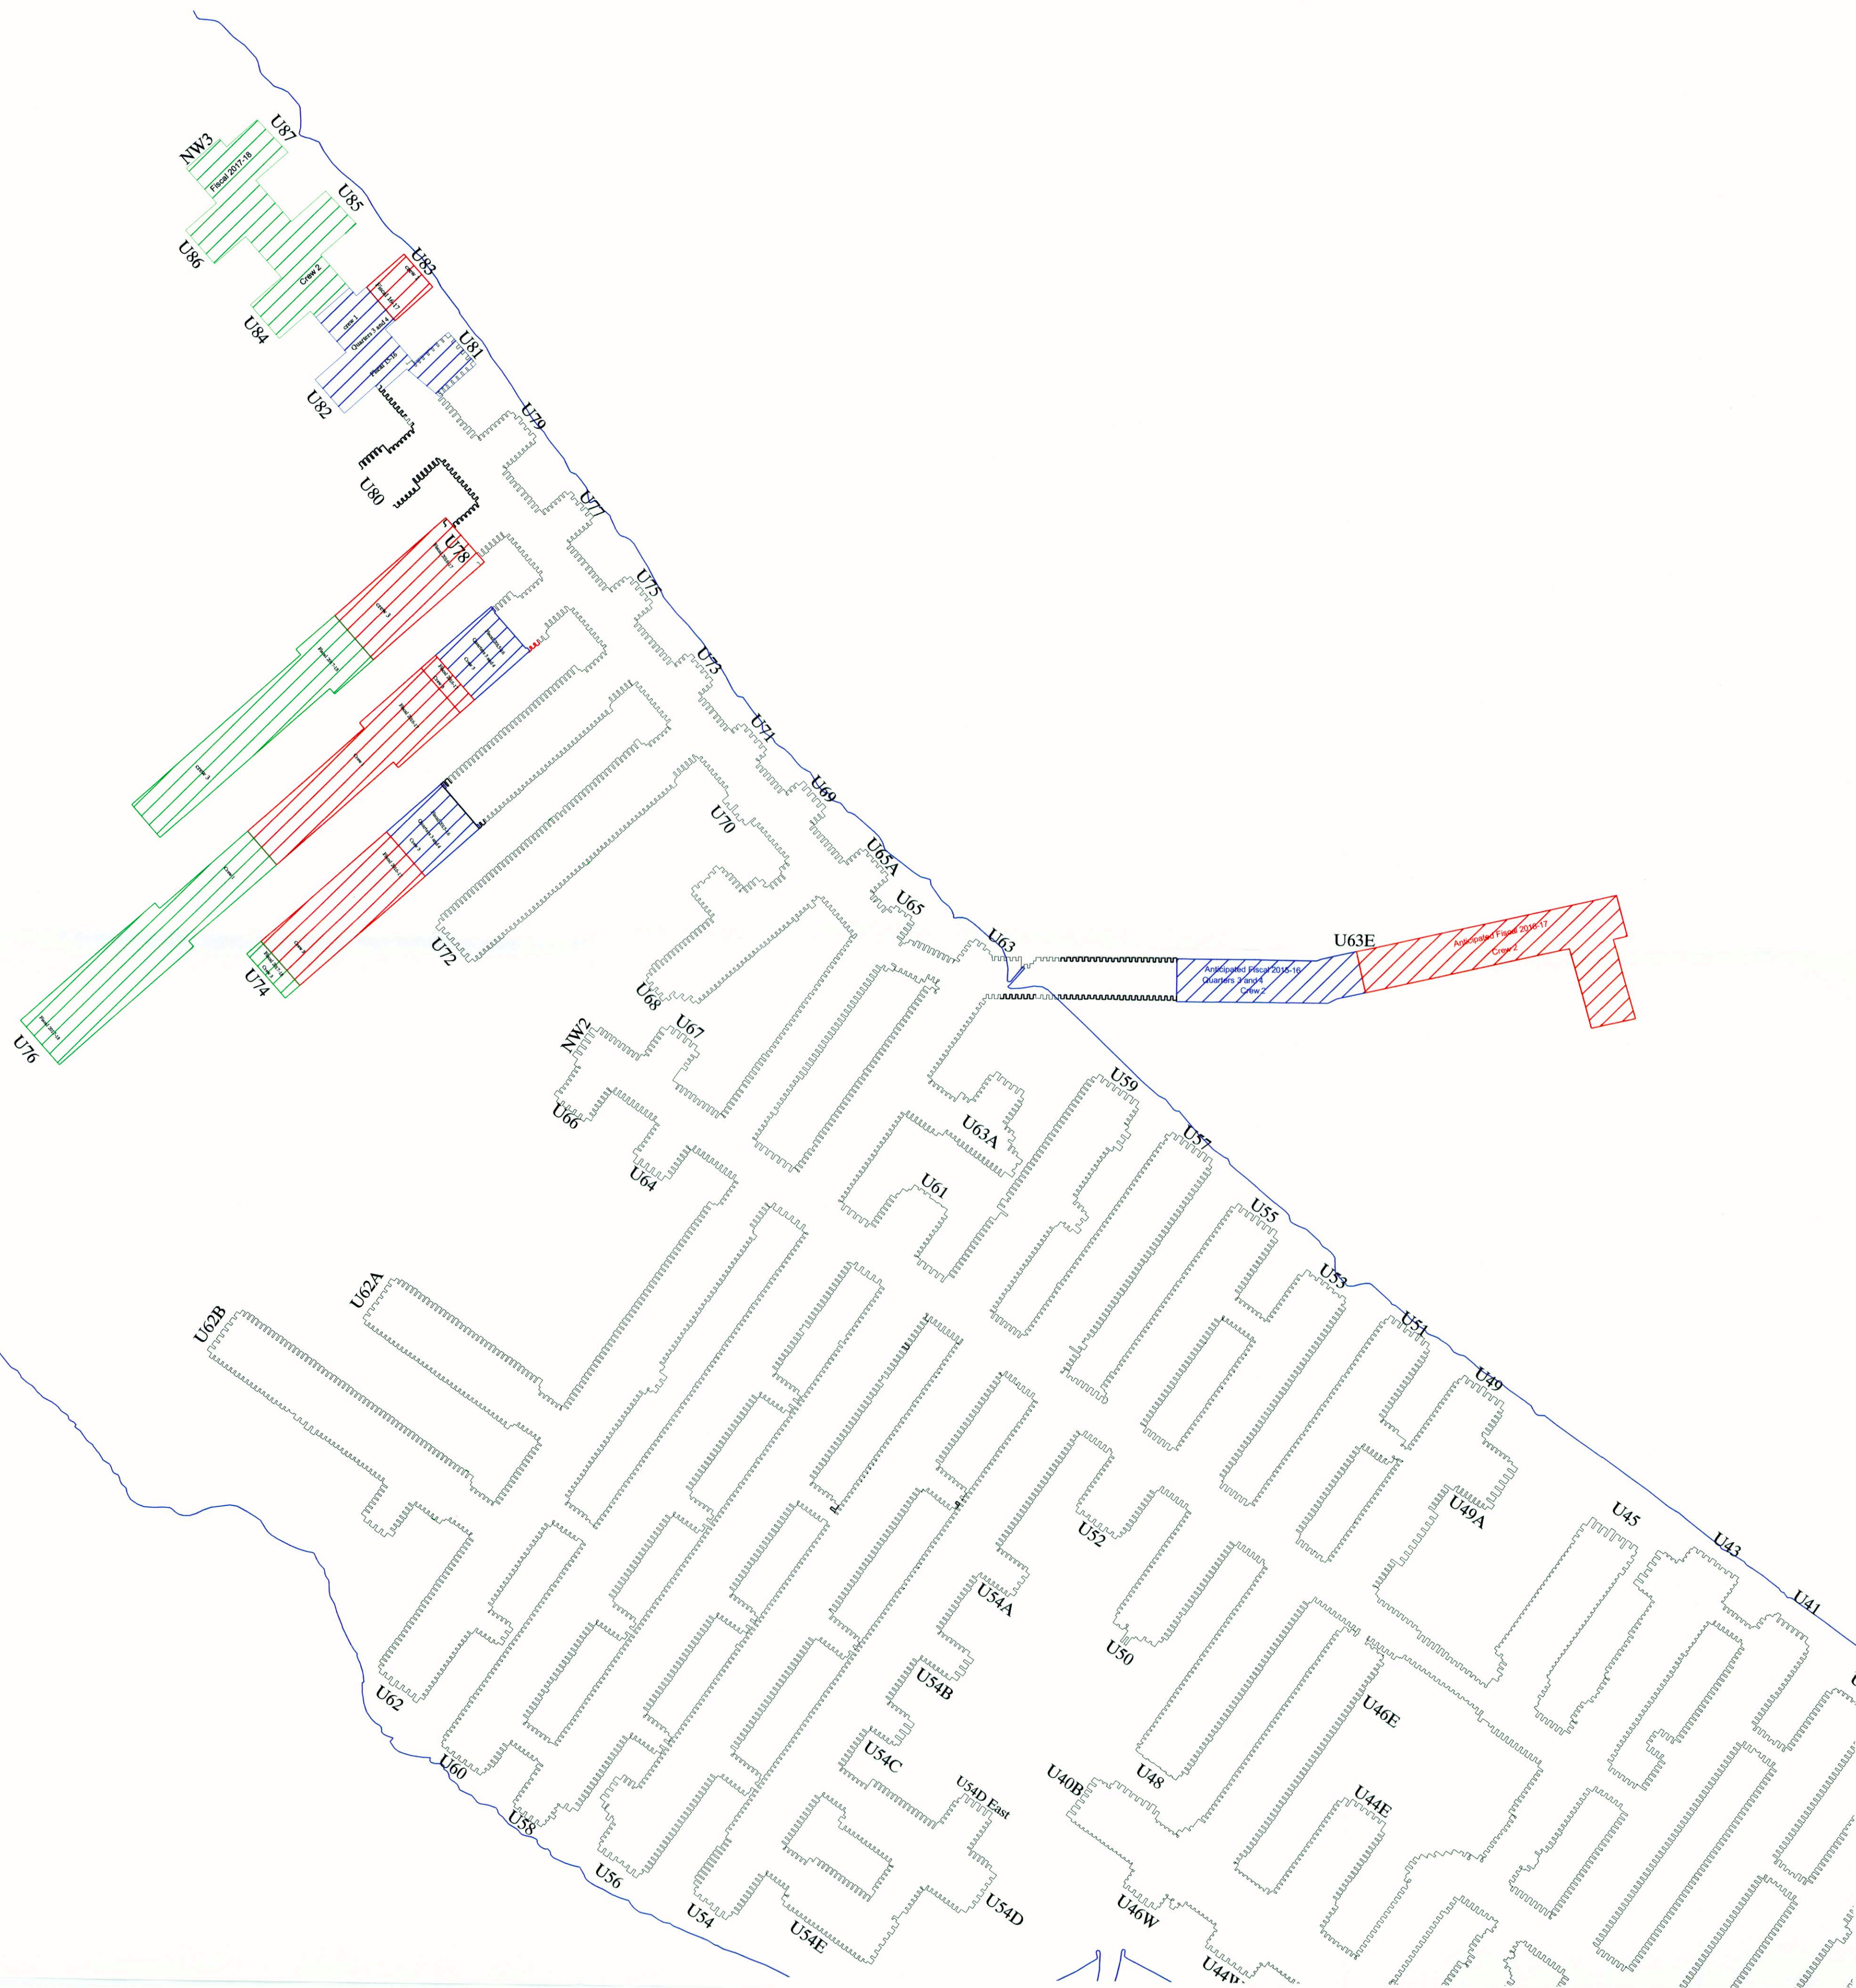
## 3 YR MINE PLAN

A map is attached depicting the current and proposed mining for the next three years.

The Cayuga Mine is currently operating in the northern region of the mine. Active mining is located in panels U-63E to the east under the land, U-74 and U-76 to the west, and NW-3 to the northwest.
