January 30, 2015

RE: Comments for the Record  
Cayuga Operating Company, LLC  
SPDES Permit NY0001333  
DEC No. 7-5032-00019-00004  
228 Cayuga Drive, Lansing, New York

## Technical Findings

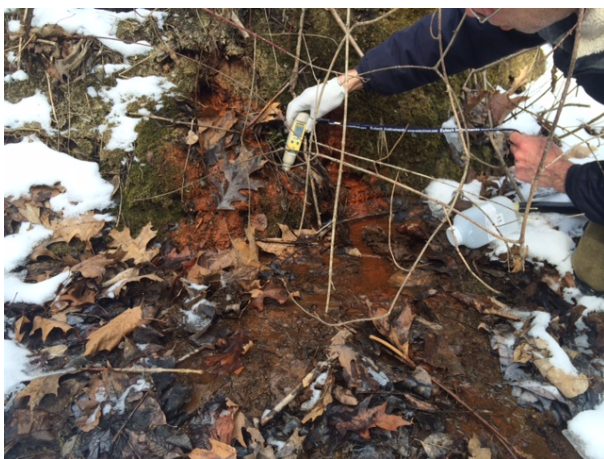
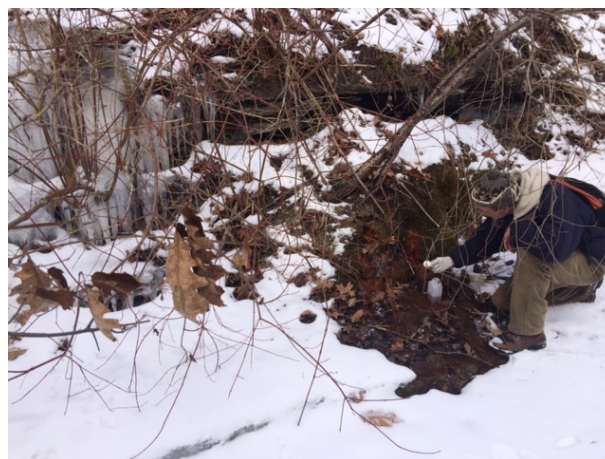
70. Another investigation performed by Dr. John Dennis along the streamline of Milliken Creek and the surrounding landfill area on January 24 and 25, 2015 identified at least one unpermitted groundwater discharge into Milliken Creek in the landfill area. Prominent, frozen groundwater seepage along the northern landfill side of the creek was visible, but due to the snow coverage and frozen conditions, a more complete inspection could not be performed.
71. Visual observations of the stream bank indicated that contaminated groundwater and / or leachate may be entering the creek through groundwater in the glacial till and bedding planes along the stream.

72. Sediment at the Milliken Creek seep was reddish-brown in color – characteristic of typical coal combustion waste groundwater-to-surface water discharges.

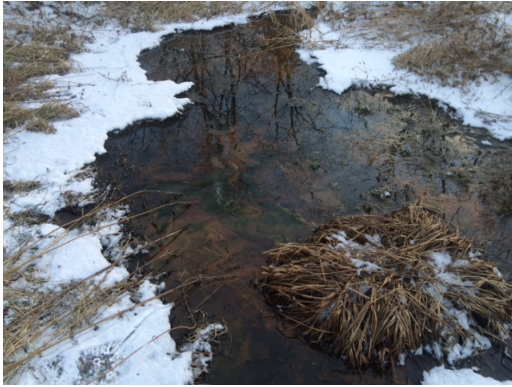
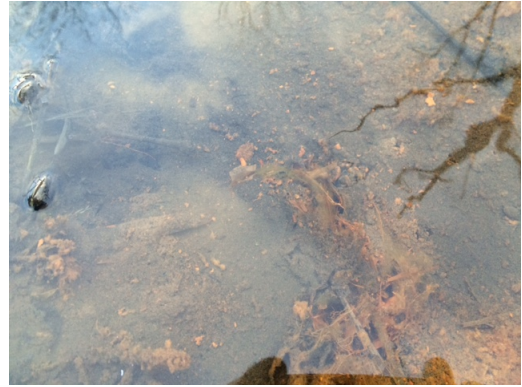
73. Dr. Dennis also identified another suspected unpermitted discharge of coal related constituents approximately 275 feet south of the plant's coal pile storage area. As was observed at the Milliken Creek location, sediments at that discharge location also exhibited visual characteristics of coal-related constituents. This discharge flows into Cayuga Lake.

74. Cayuga is not authorized to discharge leachate into any surface stream, other than from Outfall 013 associated with “discharge from Ash Disposal Site Sedimentation Pond (direct discharge to Cayuga Lake) and from the emergency overflow from that pond (Outfall 014). As such, any additionally identified discharges into Milliken Creek – if confirmed to be leachate or contaminated groundwater – would be a violation of the SPDES permit.
75. Subpart 360 for the landfill also considers discharges of leachate to either groundwater or surface water to be illegal. Specifically, Subpart 360 requires that Cayuga design and operate the landfill in a manner to “*prevent the migration of leachate into surface water or groundwater*”.

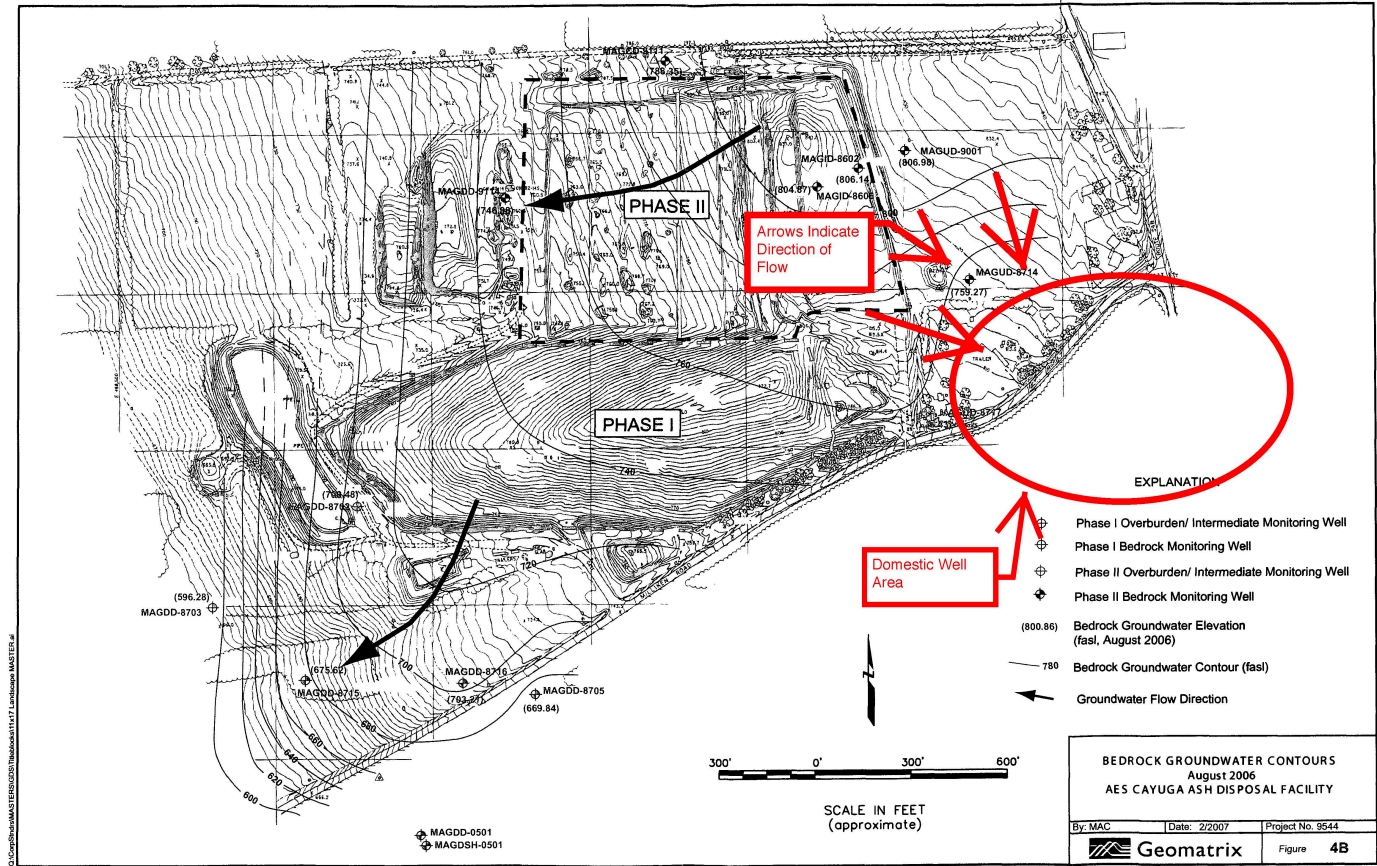
Figure 1  
Potentiometric Surface Diagram (Modified)  
August 2006

22. Although groundwater flow diagrams produced by Cayuga have illustrated a south-southeast bedrock groundwater flow direction<sup>5</sup> *towards residential properties with domestic water supply wells*, there is no indication that Cayuga has ever sampled those wells. See attached **Figure 1**.

60. Cayuga’s conclusion in 2010 that MAGUXX-8303 and MAGUXX-7712 are “upgradient” and therefore do not represent groundwater flowing from beneath the landfill is not based upon fact or their own data. When the monitoring program at the landfill included more wells in that area (e.g. 2006, before wells were destroyed to construct a portion of the Phase 2 landfill), those bedrock wells are clearly hydraulically *downgradient* of both Phase 1 and Phase 2<sup>16</sup>. See attached **Figure 1**.

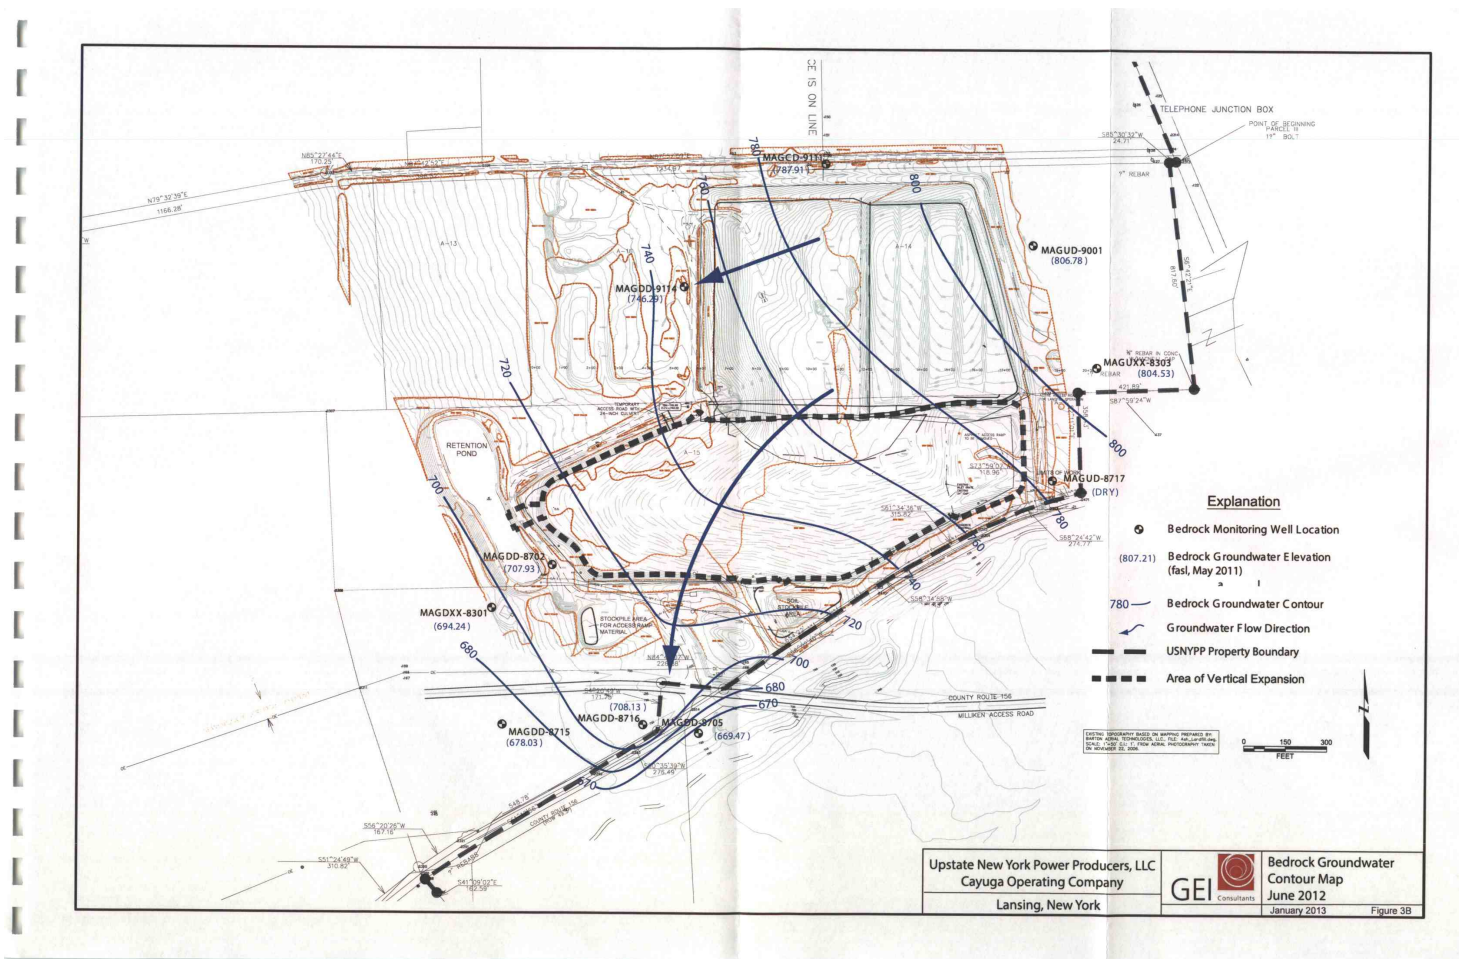
**Figure 2**  
**Potentiometric Surface Diagram**  
**June 2012 Bedrock Aquifer**

23. Cayuga’s most recent Environmental Monitoring Plan (2014) illustrates a dominant direction of flow instead towards the west-southwest. See attached **Figure 2**.

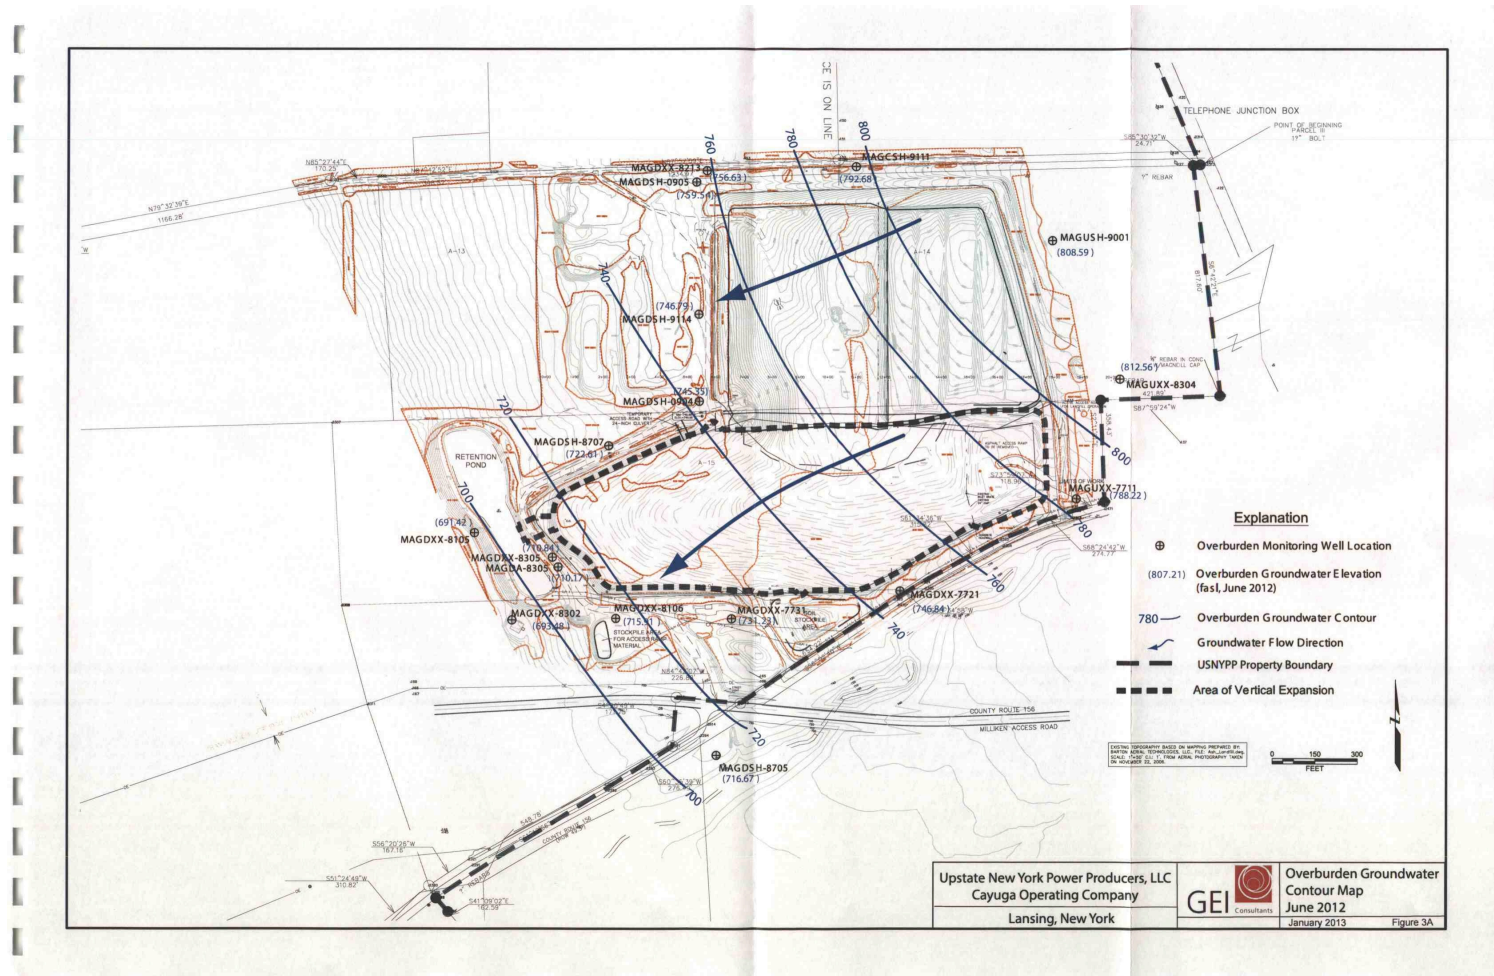
**Figure 3**  
**Potentiometric Surface Diagram**  
**June 2012 Overburden Glacial Till Aquifer**

25. Cayuga has concluded that glacial till groundwater from the landfill discharges into Milliken Creek – a stream that is incised into bedrock - through seepage along the stream bank and along bedrock fractures. Potentiometric surface maps developed by Cayuga for sampling events however, do not illustrate that soil aquifer direction of flow. See attached **Figure 3**.
