RE: Comments for the Record  
Cayuga Operating Company, LLC  
SPDES Permit NY0001333  
DEC No. 7-5032-00019-00004  
228 Cayuga Drive, Lansing, New York

Attachment: Technical Findings

## Technical Findings

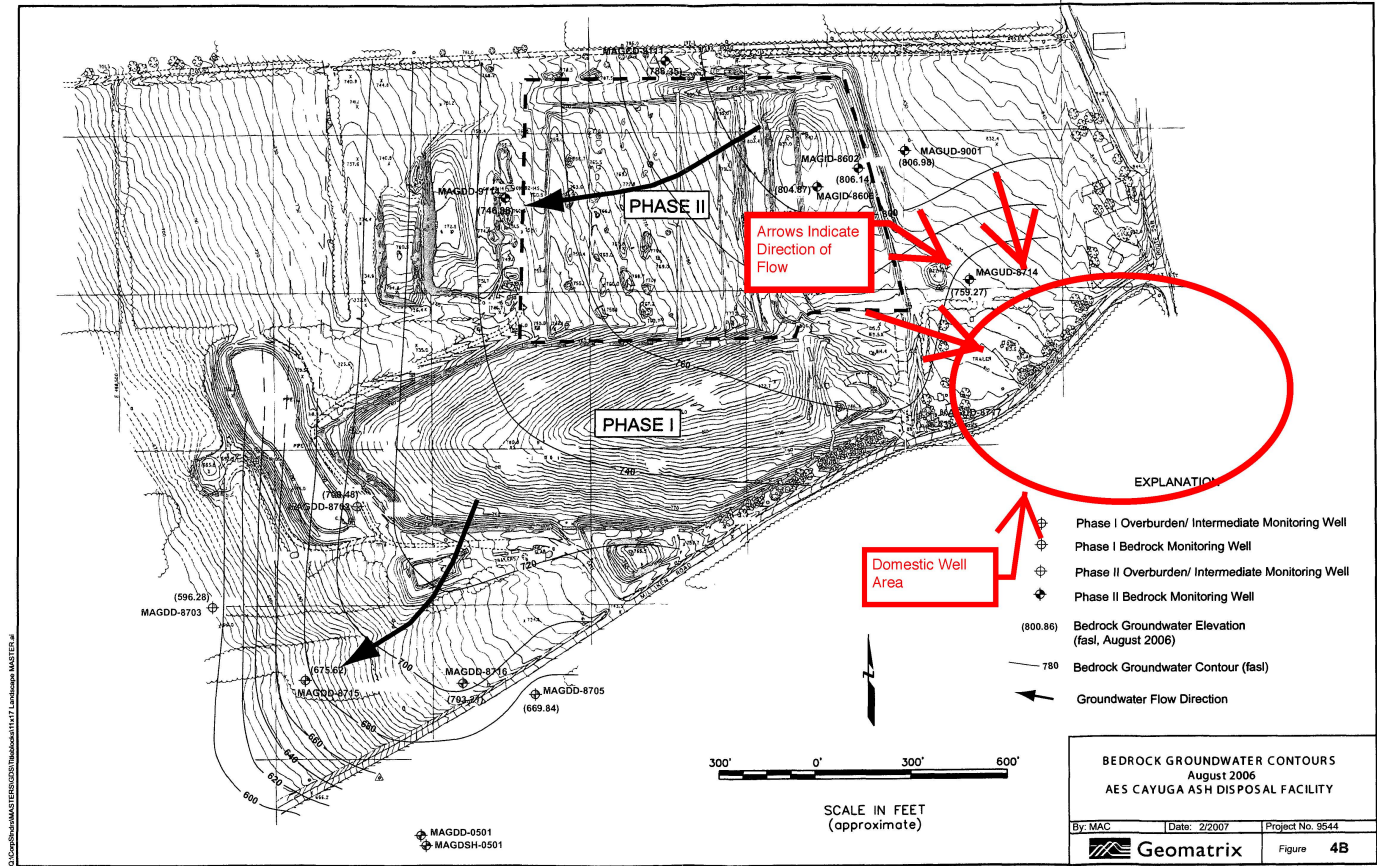
Figure 1  
Potentiometric Surface Diagram (Modified)  
August 2006

22. Although groundwater flow diagrams produced by Cayuga have illustrated a south-southeast bedrock groundwater flow direction<sup>5</sup> *towards residential properties with domestic water supply wells*, there is no indication that Cayuga has ever sampled those wells. See attached **Figure 1**.

60. Cayuga’s conclusion in 2010 that MAGUXX-8303 and MAGUXX-7712 are “upgradient” and therefore do not represent groundwater flowing from beneath the landfill is not based upon fact or their own data. When the monitoring program at the landfill included more wells in that area (e.g. 2006, before wells were destroyed to construct a portion of the Phase 2 landfill), those bedrock wells are clearly hydraulically *downgradient* of both Phase 1 and Phase 2<sup>16</sup>. See attached **Figure 1**.

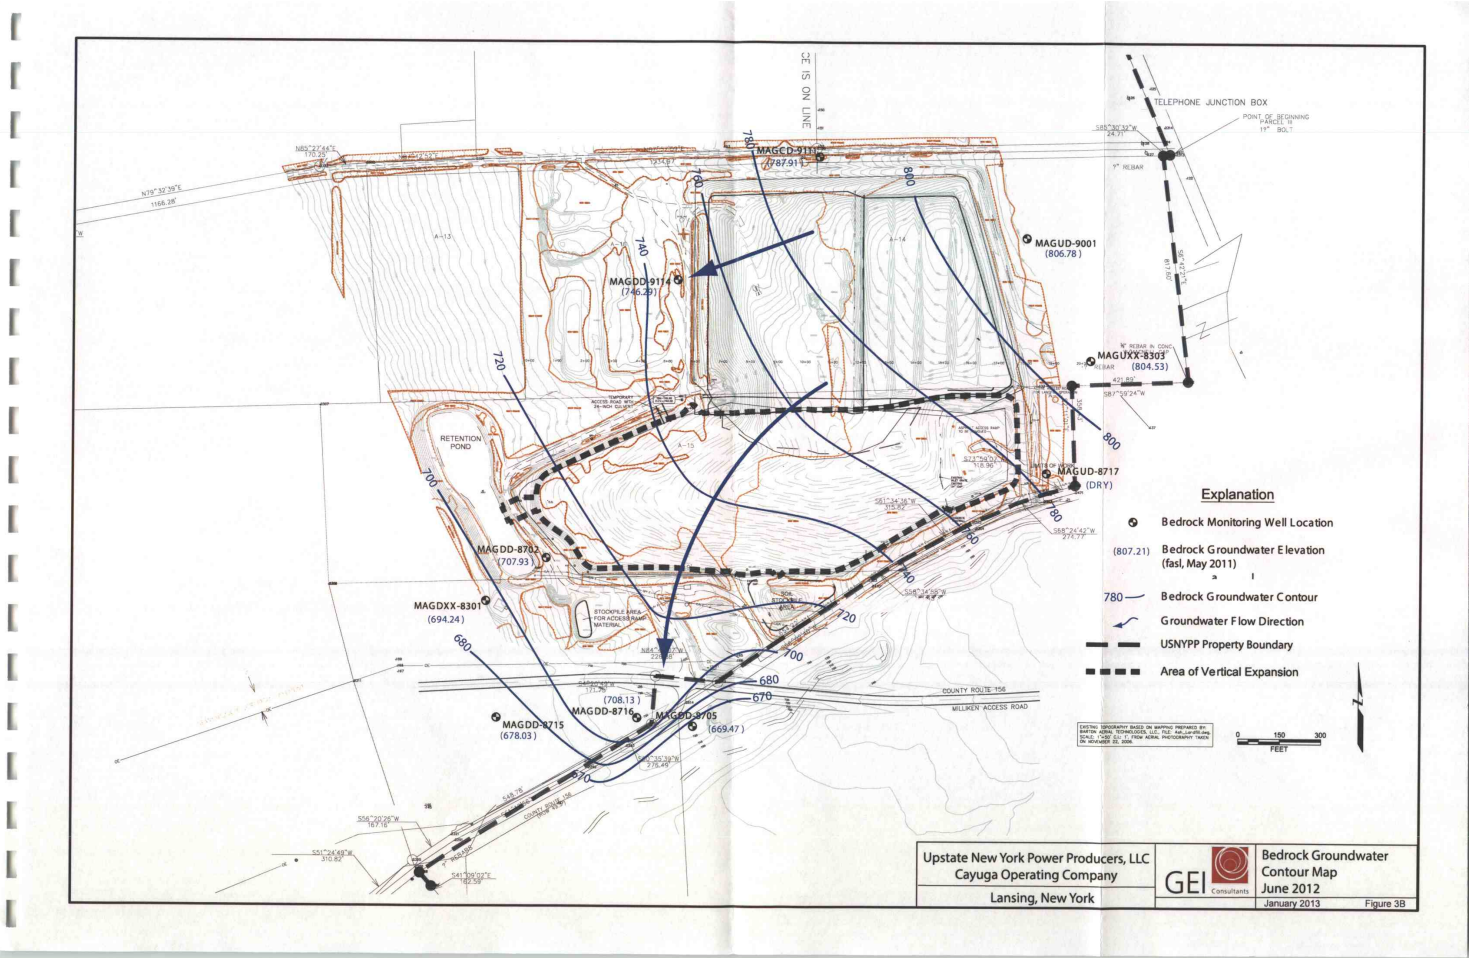
**Figure 2**  
**Potentiometric Surface Diagram**  
**June 2012 Bedrock Aquifer**

23. Cayuga’s most recent Environmental Monitoring Plan (2014) illustrates a dominant direction of flow instead towards the west-southwest. See attached **Figure 2**.

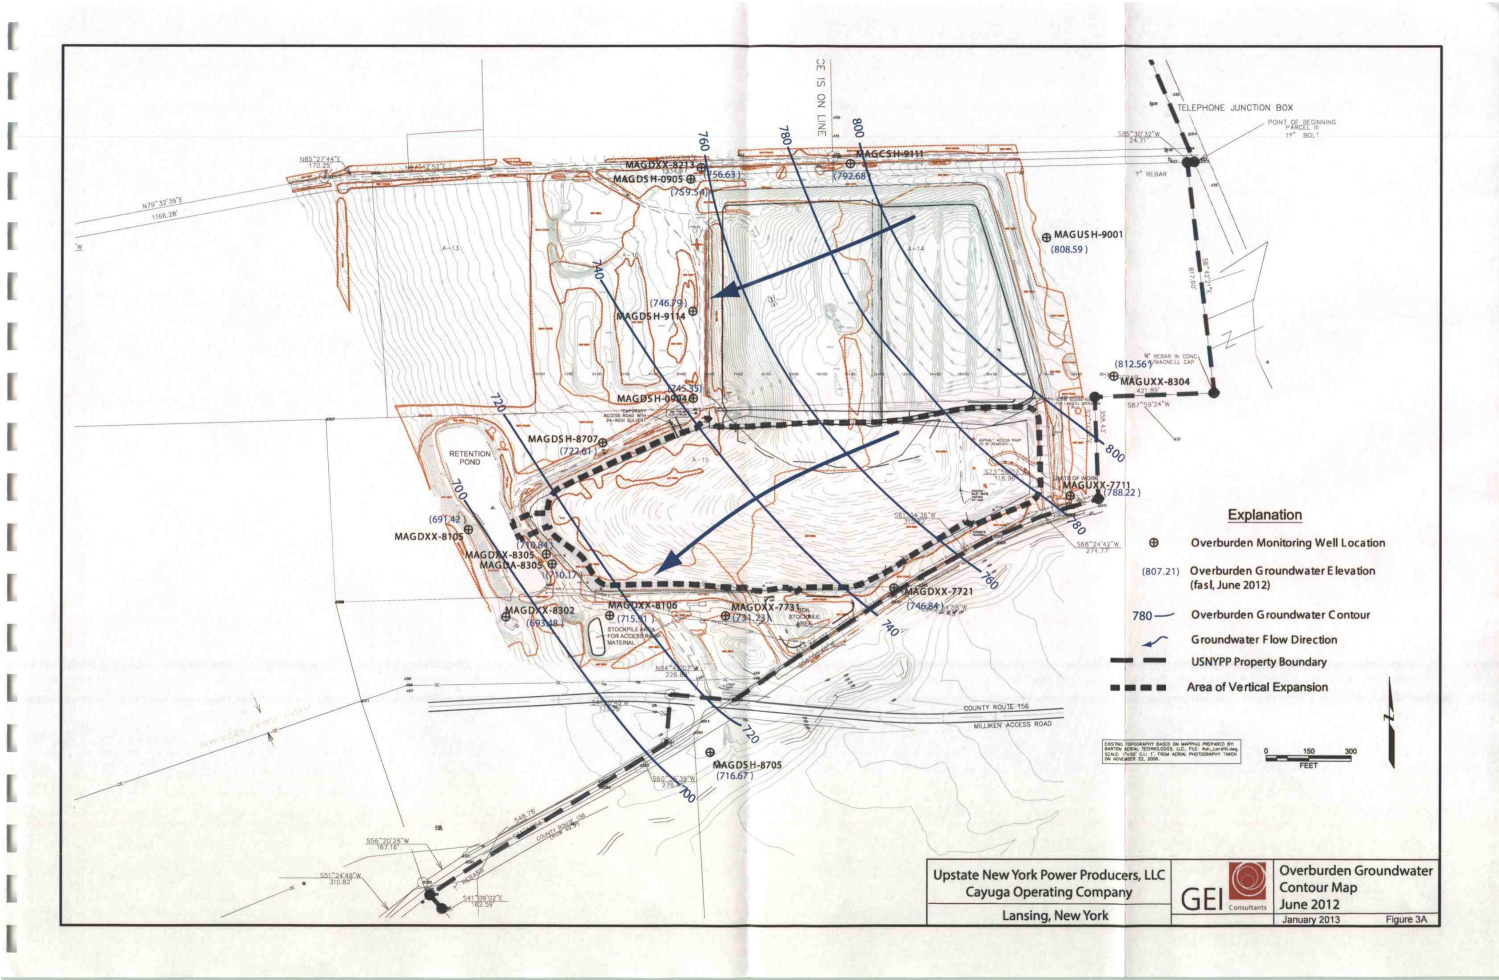
**Figure 3**  
**Potentiometric Surface Diagram**  
**June 2012 Overburden Glacial Till Aquifer**

25. Cayuga has concluded that glacial till groundwater from the landfill discharges into Milliken Creek – a stream that is incised into bedrock - through seepage along the stream bank and along bedrock fractures. Potentiometric surface maps developed by Cayuga for sampling events however, do not illustrate that soil aquifer direction of flow. See attached **Figure 3**.
