Salt Mining and Possible Future Problems in the Cayuga Lake Region:

Integration of public-domain seismic with known salt geology

Angus Ferguson
and
John K. Warren

July 2017

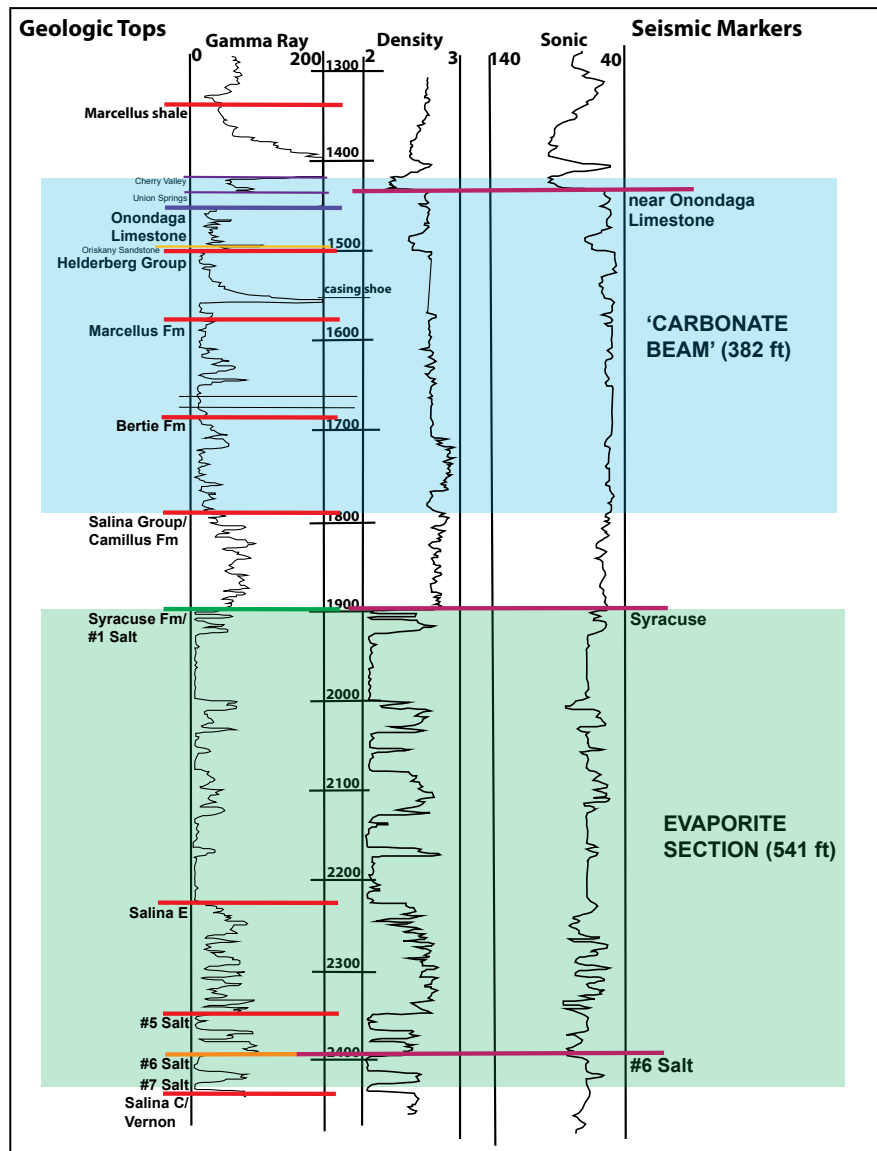
Figure 1. Seismic scale units, based on the geology intersected in Corehole 18. This borehole is the stratigraphic test well drilled to define geological conditions at the proposed lake-side position of Shaft #4.

is composed of softer units with lower mechanical strengths and is made up mostly of interlayered evaporite and shale units. For seismic interpretation, a sub-interval of the Salina Group, which starts at the Syracuse Formation, is termed the Evaporite section (Figure 1).

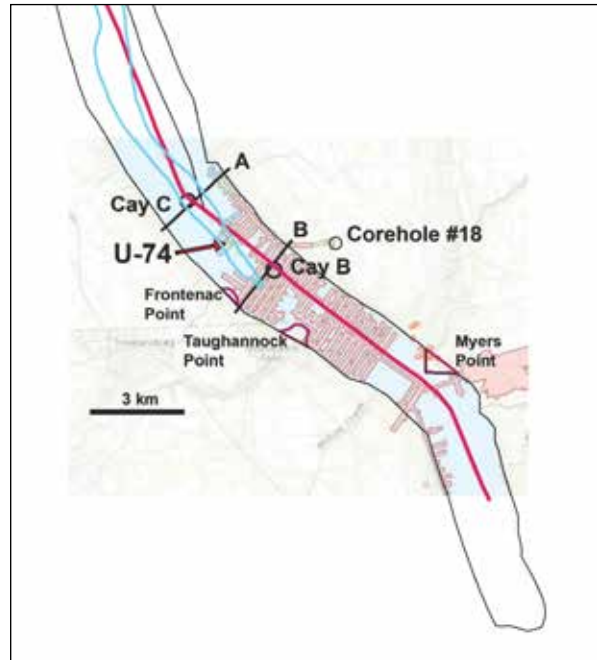
Figure 2. Onondaga subcrop in blue from Ferguson, 2017, profile locations from Spectra Environmental Group, 2000 and mine extent from Edelstein, 2017.

Mining at Himrod was conducted in a room and pillar system, which required the significant close-spaced bolting of the roof. Jacoby (1977) noted many areas of the roof were so unstable as to require bolting through mesh and bars on much closer centres than normal for most salt mines. After extraction of the salt had been completed in an area, large portions of the mine were then closed off as a precautionary safety measure due to roof stability problems. Historically, roof stability has not been a significant problem over most of the southern extent of the Cayuga salt mine, where mined-out rooms were not subject to roof collapse for periods of twenty years or more (Prucha, 1968). However, in the older, now inactive, eastern portion of the Cayuga Mine roof-falls were a problem. It is probably not a coincidence that when Cargill began experiencing ceiling fall issues in Panel U-74 in 2016, their northern mining face had advanced into the zone of significant roof beam thinning, as outlined in seismic (Figure 2).

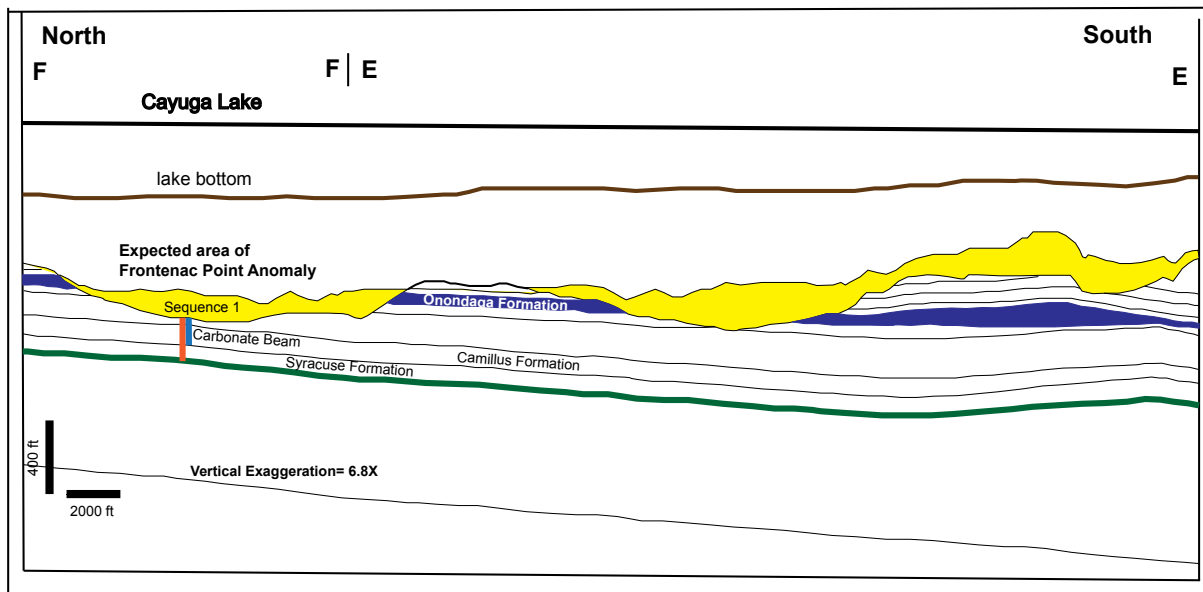
Figure 3. Profile F-E summarized from Spectra Environmental Group 2000 report.

The along-valley Profile E-F in Figure 3 shows two areas of erosion of the carbonate beam at the Onondaga level indicated by the blue line. This was reported in Ferguson and Warren, 2017.

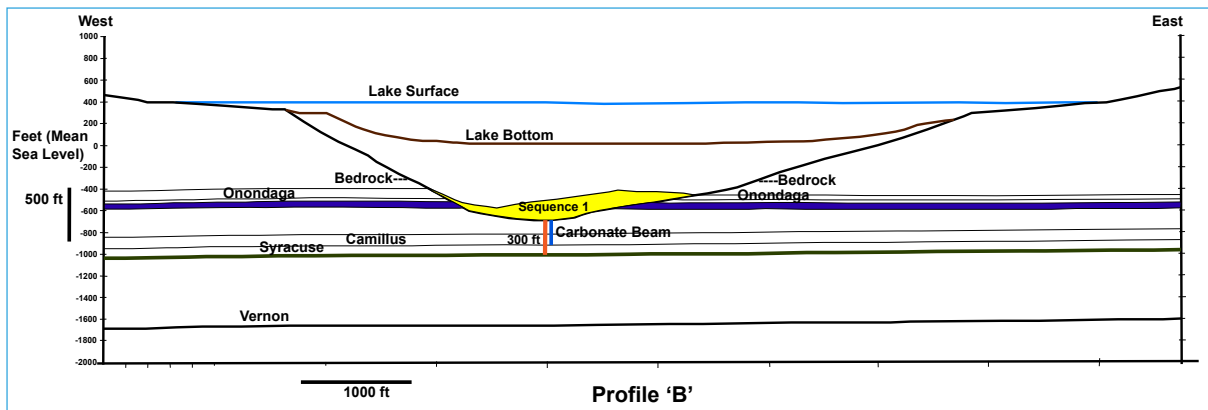
Figure 4. Profile B. Carbonate beam and Camillus Formation downcut to within 300 ft of the Top Syracuse (see text for implications).

Further profiles from the Spectra Environmental Group, 2000 are shown in Figure 4 as Profile B and in Figure 5 as Profile A. The Profiles are projections across the valley, with locations shown in Figure 2. Profiles A and B demonstrate significant erosion cutting into the carbonate beam along the deeper

parts of the valley floor. In Profile B, which is near the Frontenac Point Anomaly, the section above Syracuse Formation is reduced to 300 feet as indicated by the vertical orange line in Figure 4.

Seismic-controlled depth profiles illustrated in Figures 4 and 5 show that in places on the Cayuga Valley floor, the base of the ice that scoured the valley was separated from the Evaporite Section by vertical distances of 300 ft and 80 ft, respectively. This means that ice sheet flexuring has likely induced fracturing and jointing in intrasalt carbonate beds below the parts of Cayuga Lake where the downcut into the carbonate section is greatest as indicated by the deepest part thalweg (outlined by the blue line in Figures 2 and 6).

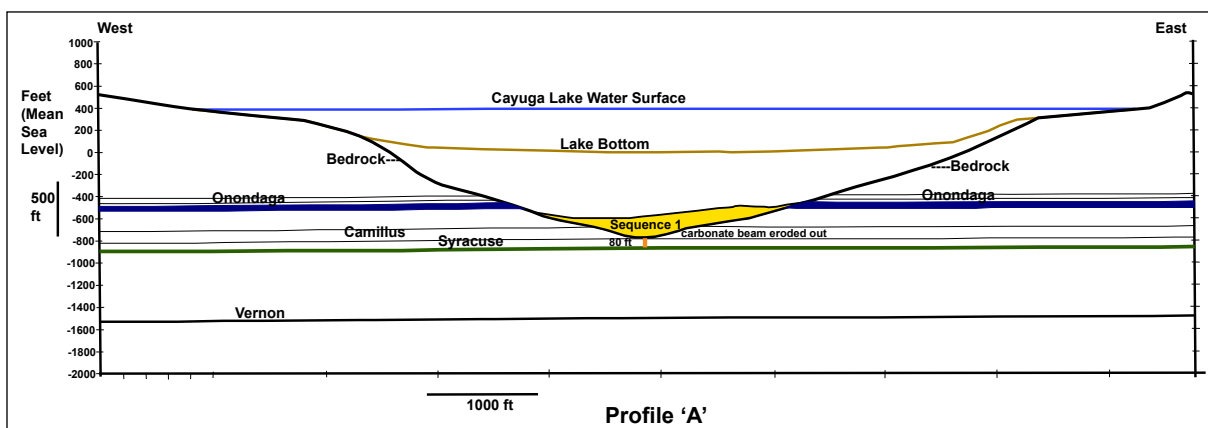
Figure 5. Profile A. Carbonate beam and Camillus Formation eroded and there is around 80 feet of sedimentary strata beneath glacial valley thalweg to the seismically-defined Top Syracuse. This situation sets up a hydrology that creates ice-flexure induced salt anomalies (see text).

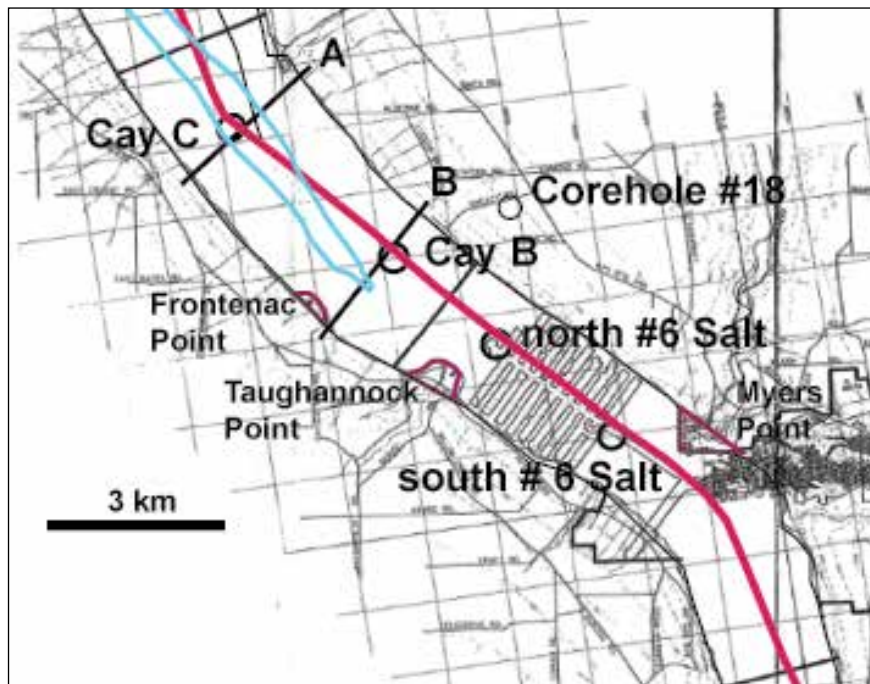
Figure 6. Red line is 2002 seismic Cay3 line. Seismic anomaly extent labelled as south #6 salt and north # 6 salt. Map from Spectra Environmental Report, 2000 shows in black the #6 salt mine footprint in 2000. Location of Profiles A and B from Spectra Environmental Report, 2000 in black.

A unique anomaly, first identified in Ferguson, 2017, is that the #6 salt level has been observed on seismic. The anomaly location is plotted in Figure 6 as north #6 salt and south #6 salt. The seismic anomaly in the 2002 seismic matches the mine location as shown in Figure 6 (outlined in black as

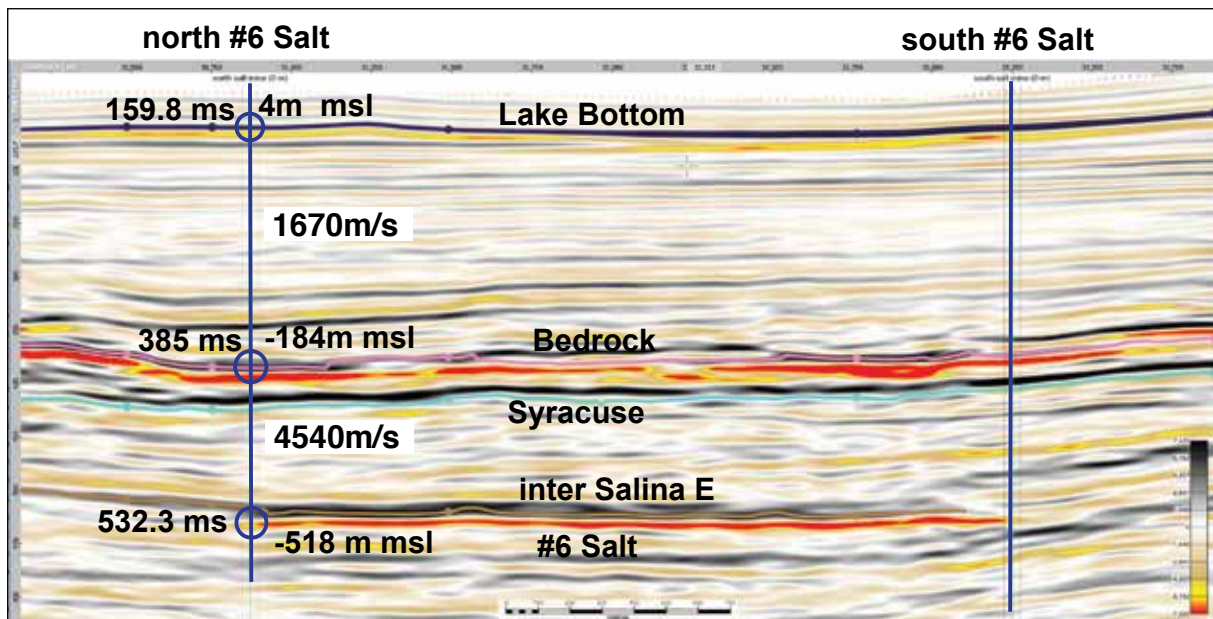
Figure 7. #6 salt level imaged on seismic as a trough- in red. General calculations of velocities shown using the measured time and depth values

the #6 salt mine footprint). This confirms that the seismic anomaly is the cavity formed by the removal of the #6 salt level which was actively being mined at the time of the 2002 seismic acquisition.

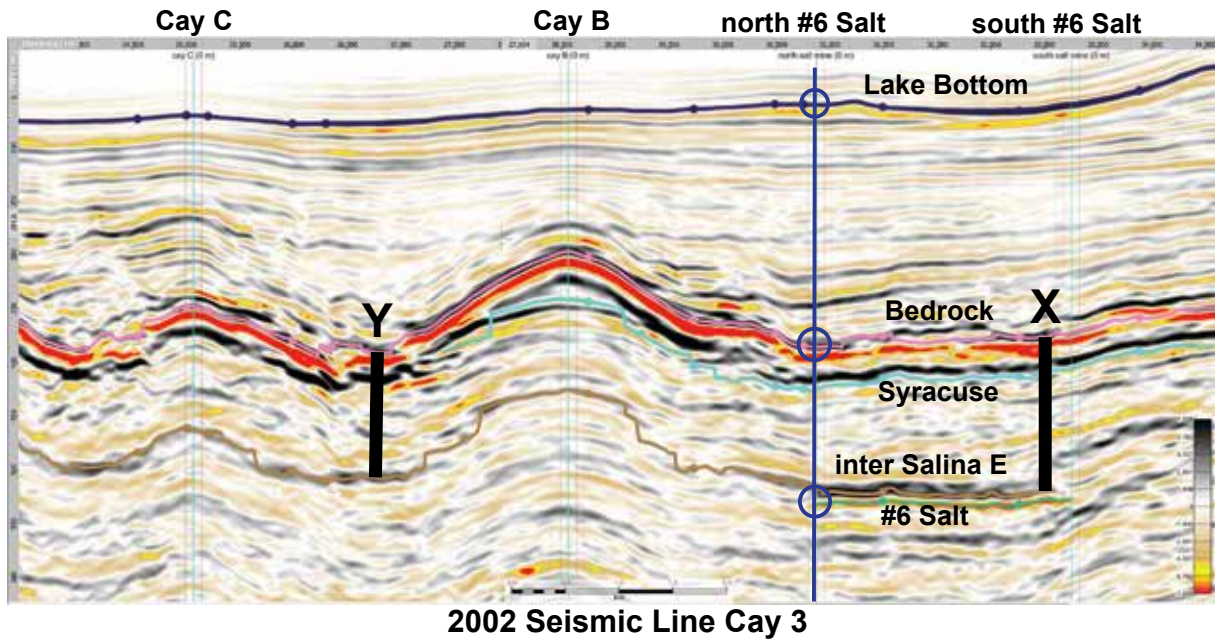
Figure 8. Seismic with horizons- thinning of carbonate beam to north, Loss of Syracuse formation

There is a thinning of the bedrock to top Salina E from the south to north. This agrees with the previous two methods and confirms a thinning of the carbonate beam overlying the evaporite unit in a northern direction. The exact thinning is difficult to calculate due to the general velocity values used. The amount of thinning is 27 ms in seismic two-

way time. This would roughly calculate as 61 m or 200 feet using the 4540 m/s interval velocity. It is expected that the accuracy of these values can be significantly improved if the seismic velocity data become available, or more seismic surveys are used.

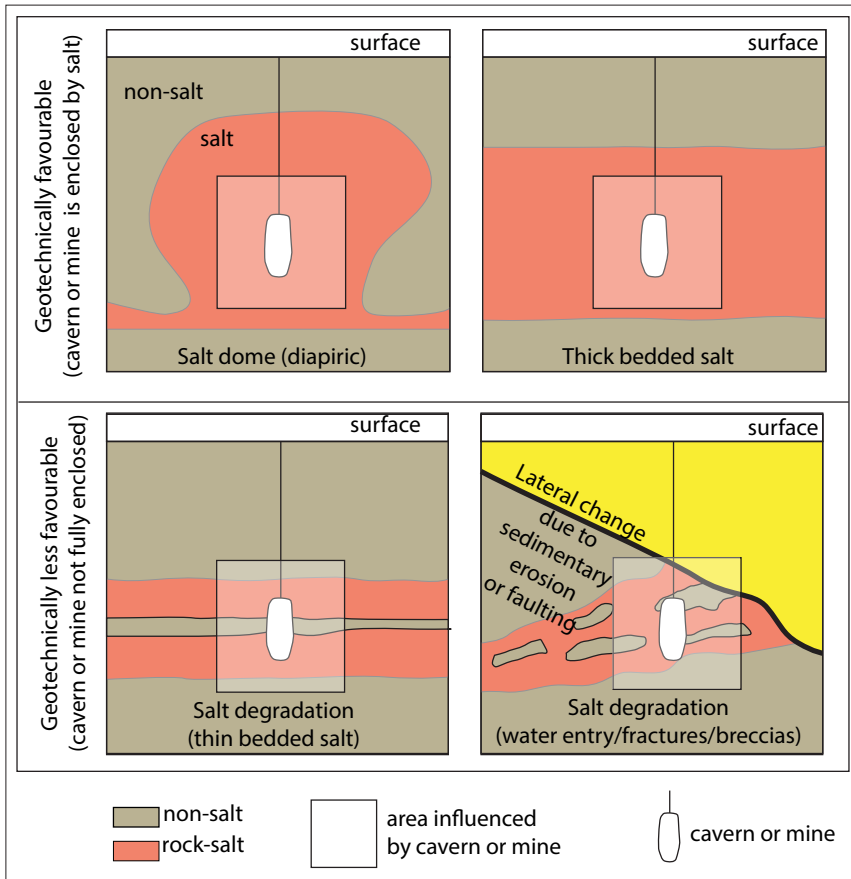
Figure 9. Schematic illustrating the concept of “Stay in the Salt.” (after Warren, 2017)

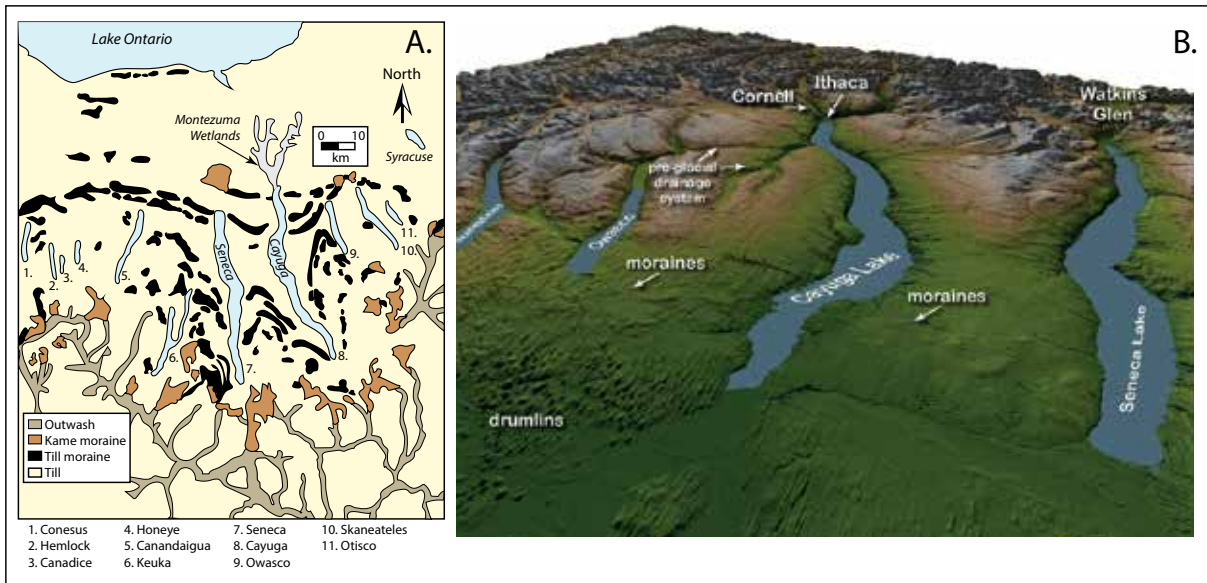
Figure 10. Finger Lakes, upper New York State. A) locality and general surface geology (after Mullins et al., 1996). B) Topography of the Cayuga Lake region looking South and showing the smoothing effects of glacial scour (extracted from images downloadable John Allmendinger's website <www.geo.cornell.edu/geology/faculty/RWA>).

base of southward flowing ice sheets eroded the future lake depression into a substrate made up of relatively undeformed, but well-jointed, Devonian sedimentary rocks, which dip gently to the south-southwest (Figure 10b).

Broad glacial valleys in the Finger Lakes region from which modern streams drain in opposite directions are called through valleys. They occur in the Finger Lakes region (Figure 10a) and are also found in many areas across the Appalachian Upland. Through valleys indicate significant glacial erosion also occurred to the south, east, and west of the Finger Lakes region and that the Finger Lake region largely preserved the geomorphic features of the last ice advance and retreat (Muller and Calkin, 1993).

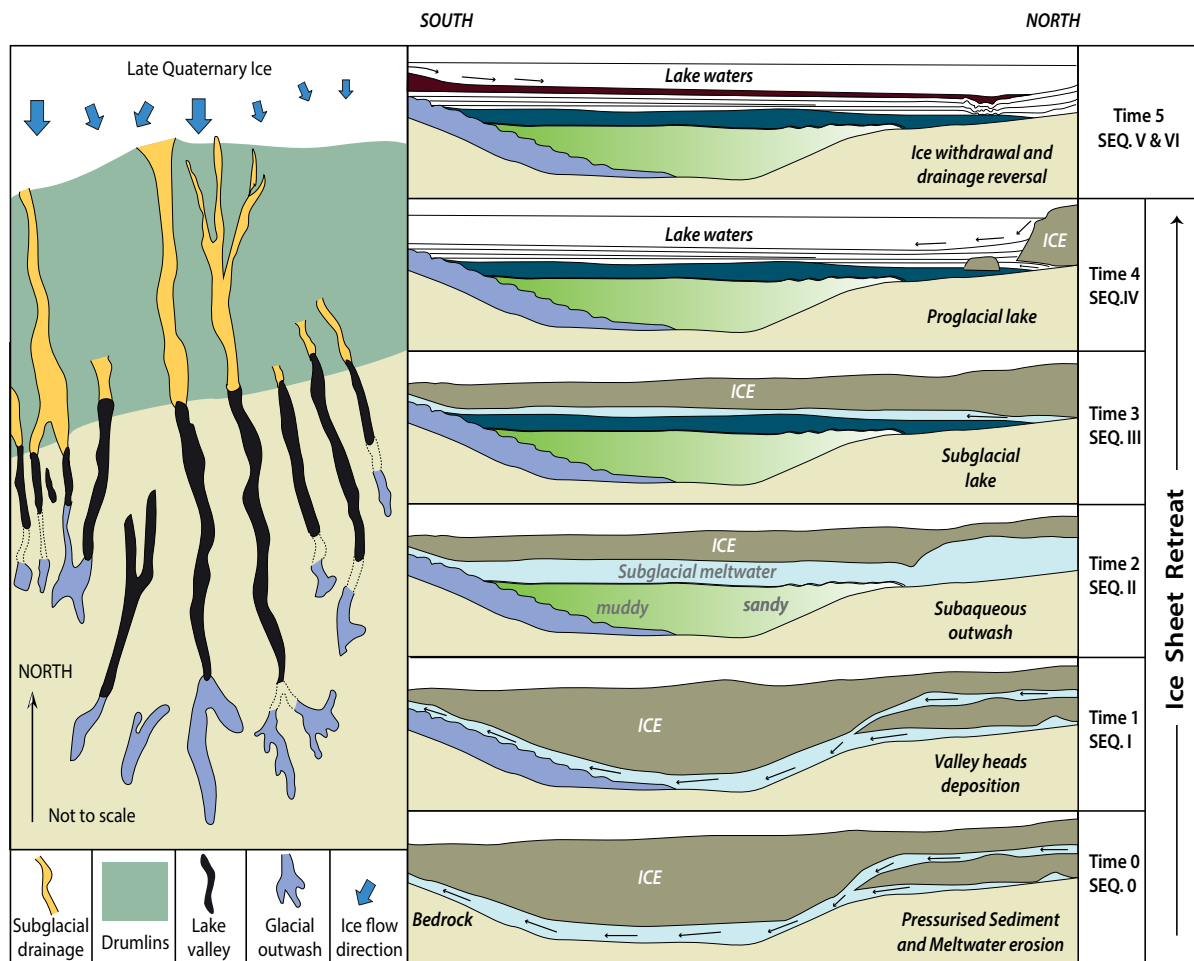
Figure 11. Geological model explaining Finger Lake valley formation as subglacial scour features (after Mullins et al., 1989). At times in the Pleistocene all the lake valleys, including Cayuga Lake, were characterised by an ice overburden that loaded the underlying sediments and so exerted additional hydropressure that abated with the melting and retreat of the ice sheets.

Glacially-driven sub-ice-base erosion was most intense beneath Seneca and Cayuga lakes, where maximum depths to bedrock are 300 m and 250 or more metres below sea level, respectively (Figure 12). The ice-retreat model currently used to explain the formation and filling of the various Finger Lakes is illustrated in Figure 11 (Mullins et al., 1989, 1996).

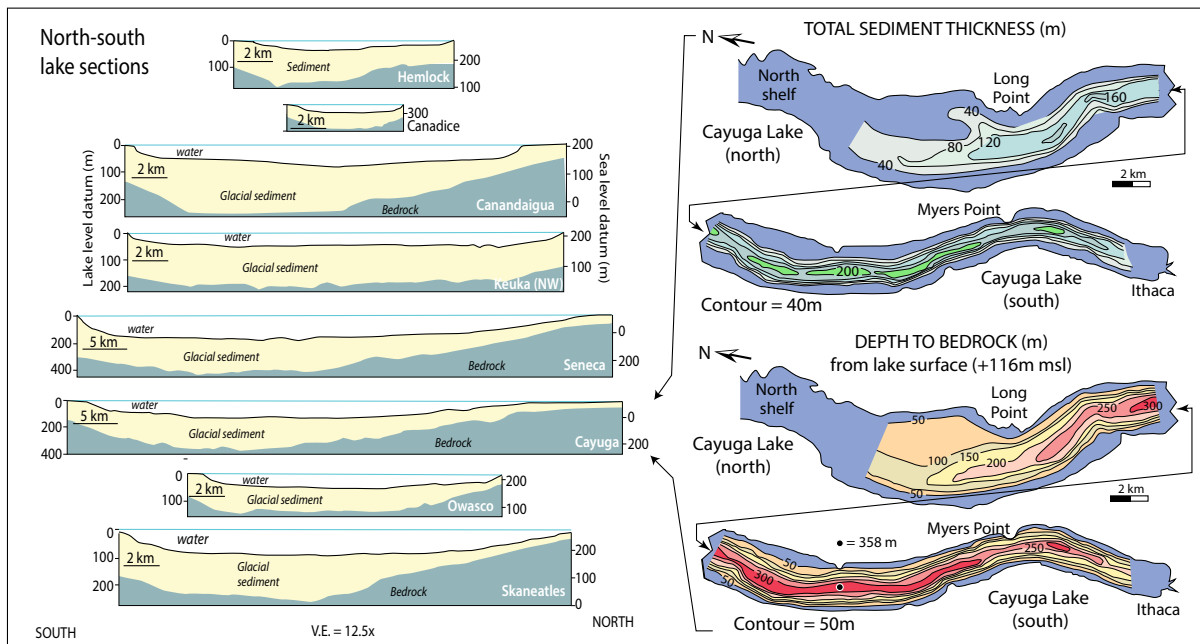
Figure 12. Section and map views of sediment fill statistics of the Finger Lakes, New York State (after Mullins et al., 1995) A) Total thickness of the glacial sediment fill in the various Finger Lakes. B) Total thickness isopach of glacial sediment fill (m) and depth to bedrock isoclinal relative to lake water surface (based on Mullins et al., 1996 seismic interpretation, this has been refined by current interpretation detailed earlier in this report).

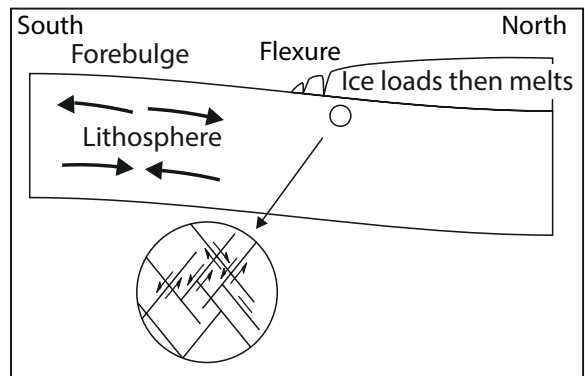
Figure 13. Schematic illustration of how waxing and waning of an ice sheet edge induces fracturing and meltwater or seawater entry into rocks below.

of feet in northern New York State (Figure 13). Marine waters entered and flooded the still-depressed St. Lawrence-Champlain Lowland to elevations as much as 325 feet (100 m) above modern sea level. This Champlain Sea lasted for about 1,700 years and gradually drained and retreated eastwards as postglacial rebound raised the area back above sea level (Pair and Rodrigues, 1993).

Ice sheet flexure zones in Antarctica and the Canadian Shield drive seawater-derived brines into the craton to depths of up to a kilometre (Figure 13; Starinsky and Katz, 2003). This flexuring opens joints and fractures and so allows fluid entry into hard rock cratonic areas that would otherwise be impermeable (Figure 14). Even in regions of homogenous hardrock substrate, there are quan-

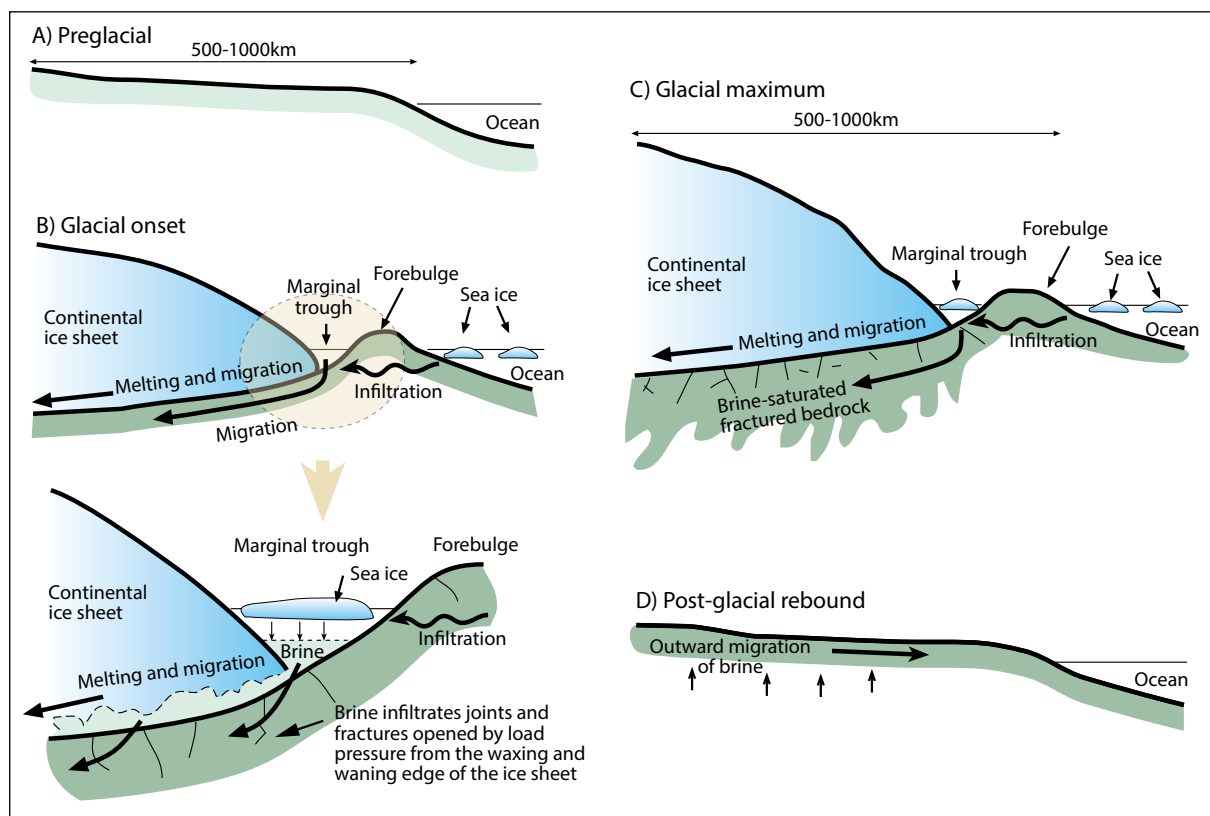
Figure 14. Isostatic and hydrological evolution of a marine-cryogenic-edge basin aquifer system: A) Continent-ocean boundary before the onset of a glacial cycle. B) An ice sheet develops on the continent, depressing the crust underneath and forming a forebulge along the coast. Seawater infiltrates into the marginal trough between the ice edge and the forebulge and sea ice crystallizes on its surface. The resultant brine sinks to the bottom and infiltrates the underlying sediments and rocks via cracks and shear zones and by non-equilibrium melting of the ice sheet base. Then, it migrates inland, along the inclined ice-rock contact, towards the center of the depression. Loss of brine from the trench is compensated by fresh seawater flow through the forebulge. C) During the glacial maximum the basement rocks below the ice sheet become saturated with brine. D) Increased melt water head developing during glacial decline, accompanied by postglacial lithospheric rebound, drive the brines outwards from the center of the glaciostatic depression to their present sites (after Starinsky and Katz, 2003).

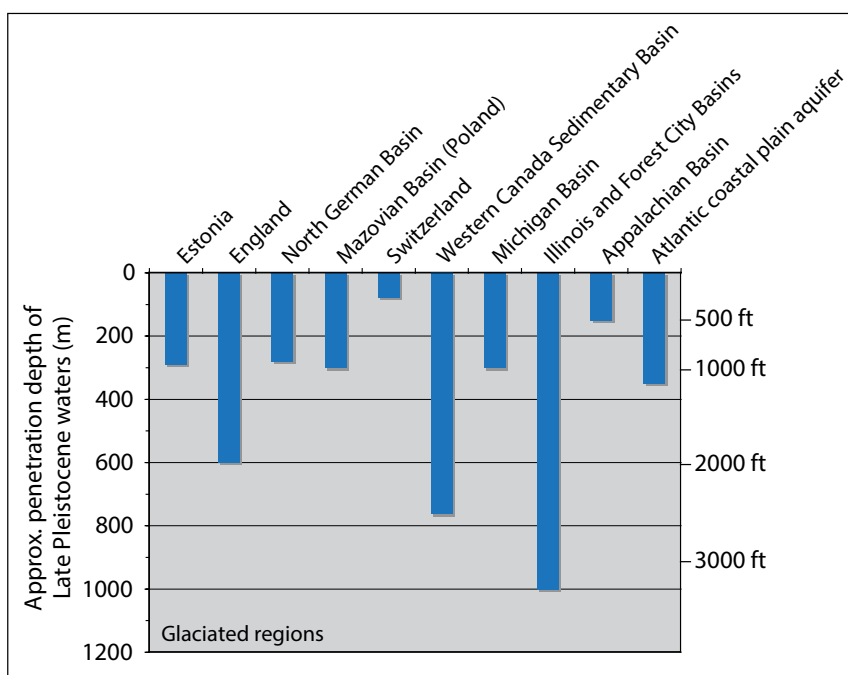
Figure 15. Reported approximate maximum penetration depths of Late Pleistocene meteoric waters in sedimentary basins across North America and Europe (from Person et al., 2012).

tified depths of fracturing and pressurised water entry measured in several hundreds of metres (Figure 15).

This is occurring in areas without the complication of thalwegs cutting deep into evaporitic substrates. However, in some of the deeper examples of water penetration, the dissolution of evaporites creates a fractured and brecciated unit that is more permeable and this facilitates even greater depths of groundwater penetration (Figure 15).

groundwater entry has been quantitatively documented in a number of regions. Figure 15 plots known depths of Late Pleistocene meltwater entry in various regions worldwide (Person et al., 2012) Depths range from 50 m (Switzerland) to a kilometre (Illinois and Forest City Basin), with penetration of a little over 300 m in the Michigan Basin and 150 m in the Appalachian basins. These latter two basins sandwich the study area, so we can assume ice sheet flexure was capable of driving groundwater penetration between 150 and 300m (~500-1000 ft) below the base of the ice sheets in the Cayuga Lake (Finger Lakes) region.

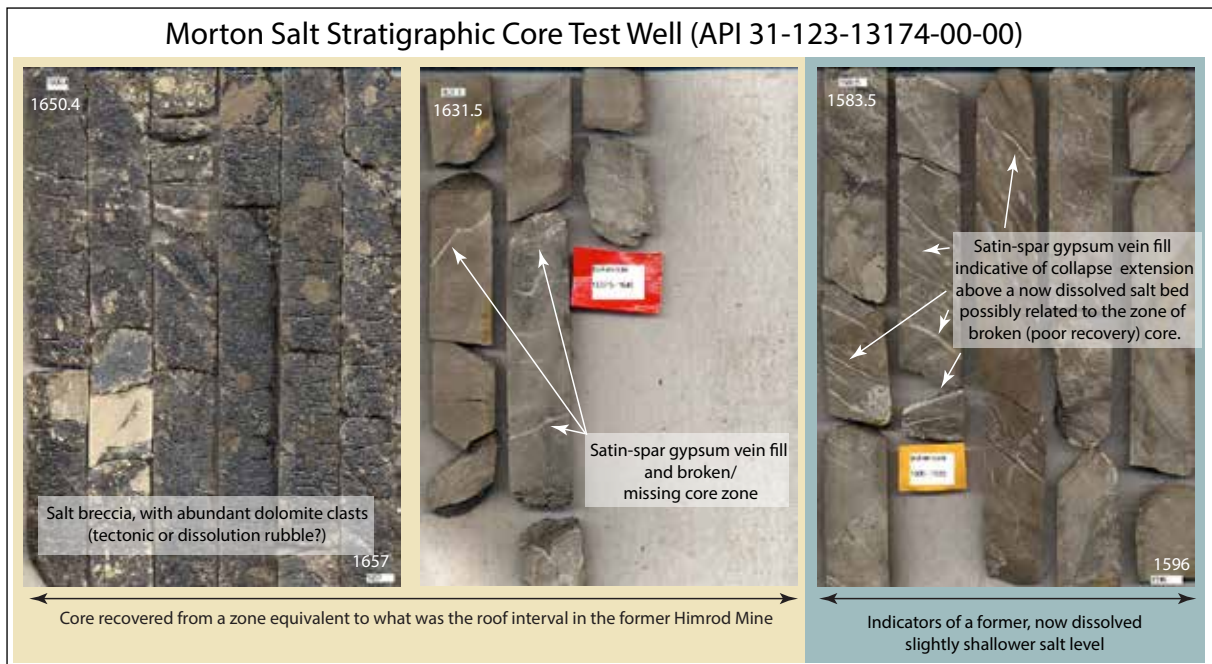
Figure 17. Rock-core based observations relevant to the nature of the top of a salt unit and indications of former, now dissolved salt levels in the Cayugan salt of the Salina Group. (Images downloaded from <http://esogis.nysm.nysed.gov/Cores_TOC.cfm>, last accessed Dec.,2016). Refer to Warren 2016b for more detail of other salt textures in this core

8 and 9 in Warren, 2016b. Based on the author's experience, all salt textures in these cores indicate that, in addition to some dissolution-induced collapse, salt in the vicinity of the Morton-Himrod Mine had earlier flowed and deformed. The salt layers now constitute a sequence of coarsely recrystallised, structurally-aligned halite layers. The layers had variable thicknesses and degrees of aquifer-induced dissolution, with dissolution effects especially evident in the upper parts of the salt interval (Figures 17).

The importance of the textures in the cores illustrated in Figure 17 is that they show aquifer connection, so assumptions of present-day isolation of the salt from fractured aquifers are not correct. These textures indicate that assumptions of no hydraulic connection between salt and fractured Palaeozoic aquifers that were assumed in the planning stage of the mine were wrong.

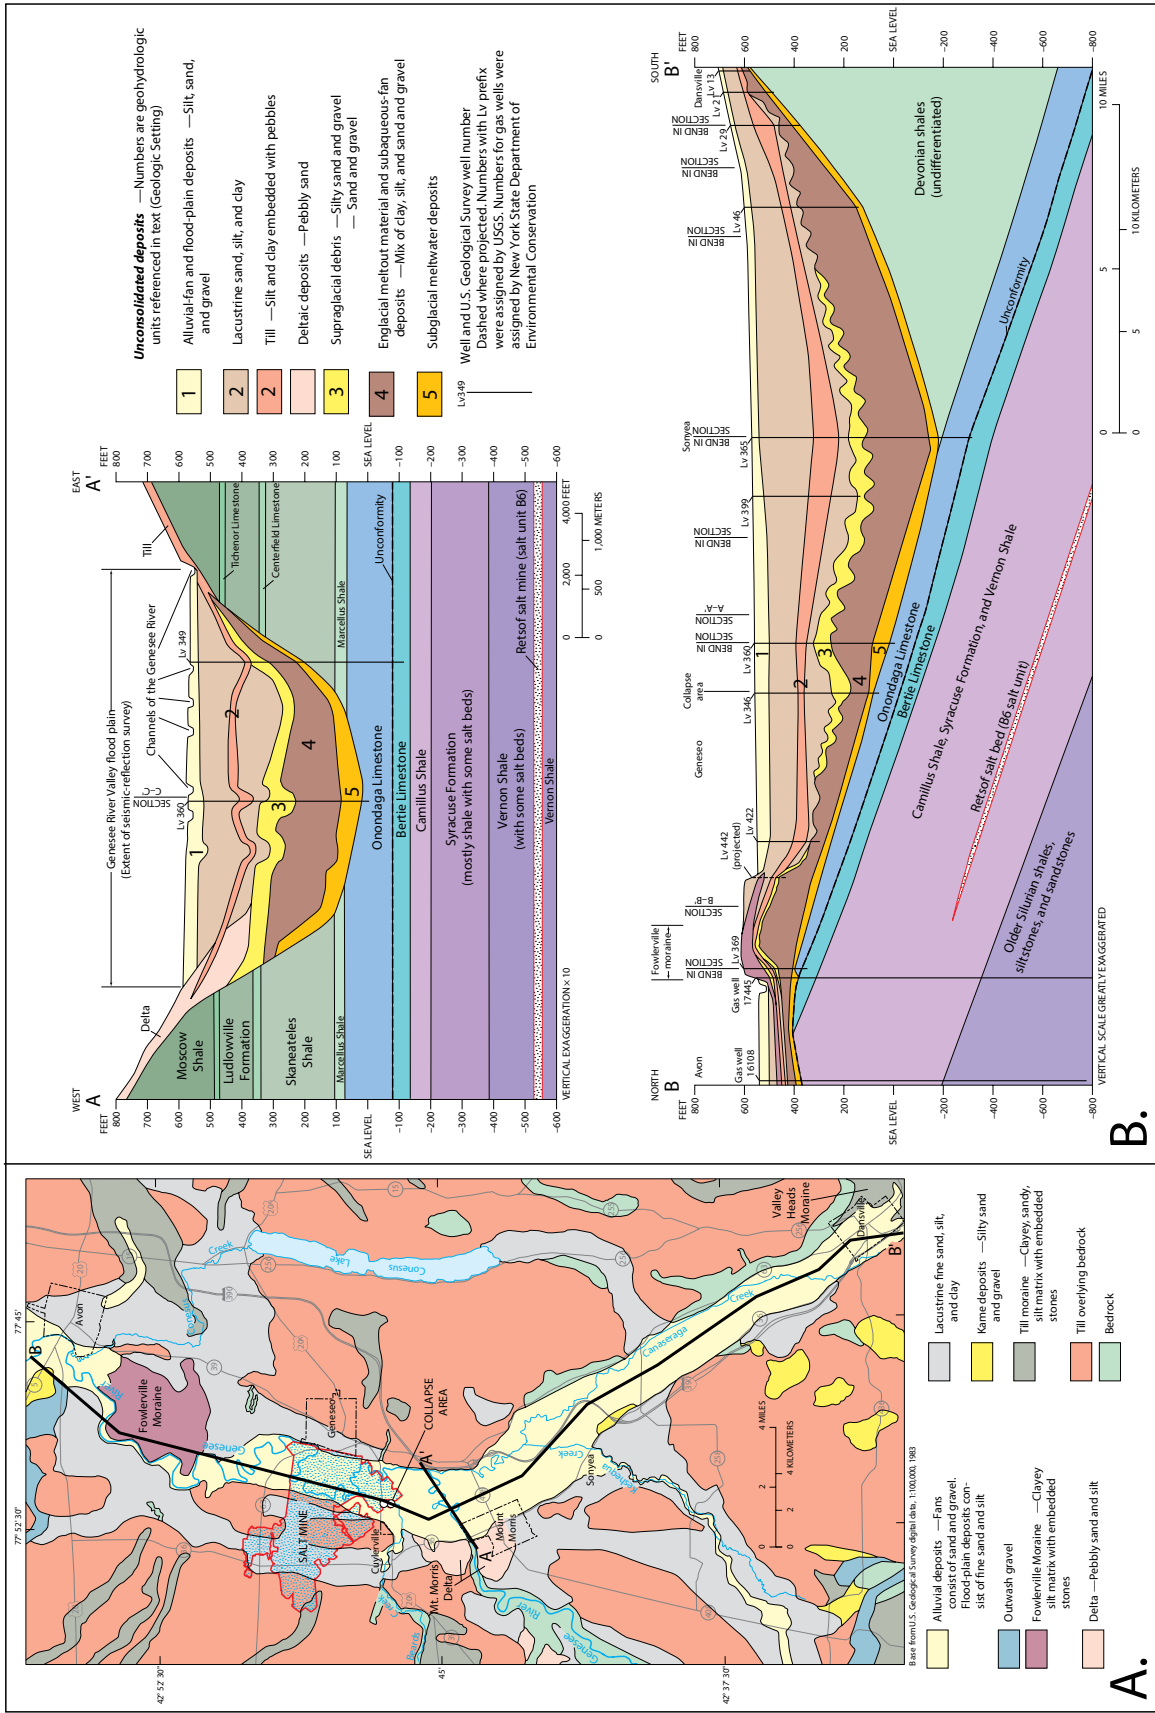
Figure 18. Geology of the Retsof Mine, The Genesee Valley and surrounds. A) Surficial geology. B) Geological cross sections. Also illustrating main Pleistocene aquifers and aquitards (after Yager, 2013; Yager et al., 2001).

lain by water-bearing zones in fractured Palaeozoic bedrock (Yager, 2001). The glacial aquifers are bounded laterally by the glacially-scoured bedrock valley walls. The uppermost aquifer consists of alluvial sediments 20 to 60 ft thick (unit 1 in Figure 18b); the middle aquifer consists of glaciofluvial sand and gravel less than 10 ft thick (unit 3 in Figure 18b); and the lower aquifer consists of glaciofluvial sand and gravel about 25 ft thick overlying the bedrock valley floor (unit 5 in Figure 18b). These aquifers are separated by aquitards dominated by muds and clays (Units 2 and 4 in Figure 18b).

Ground water within the valley generally flowed northward and updip before the mine collapse (Yager et al., 2001). The hydraulic head distribution in the confined aquifers under natural (before the mine collapse) conditions is assumed to have been similar to that in the upper aquifer before the collapse, but water levels in the confined aquifers were probably above the water table beneath the valley floor. Much of the ground water reservoir along the fractured Onondaga/Bertie Limestone contact also flowed northward to escape at the Bertie Limestone subcrop, now located in the valley north of the Fowlerville Moraine (Figure 18).

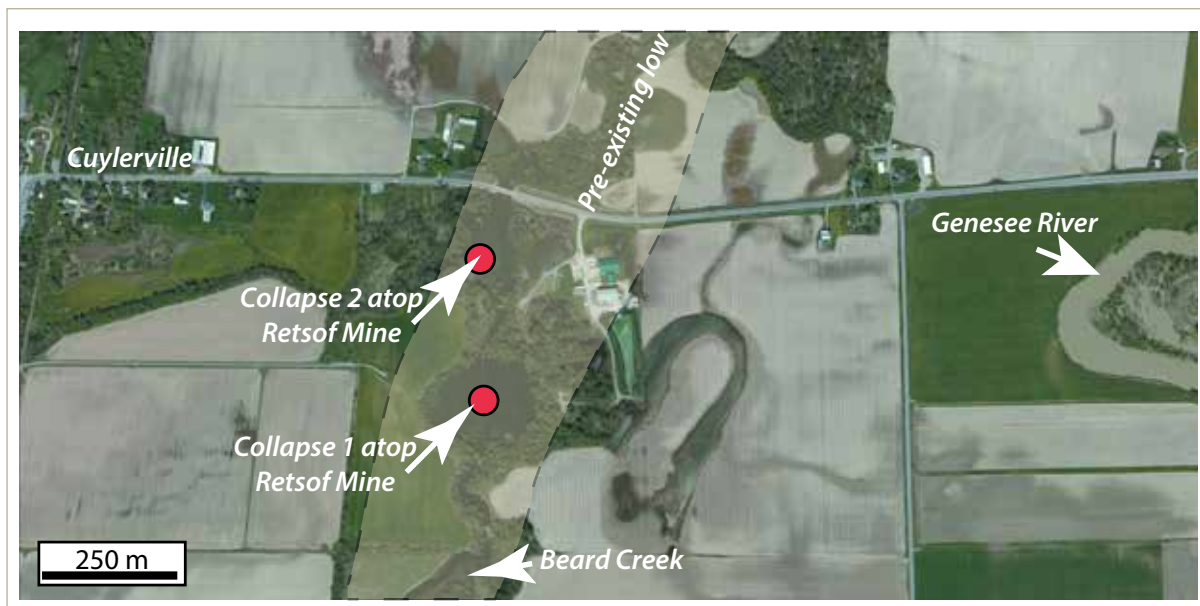
Figure 19. Location of the collapse dolines atop the former Retsof Mine to the east of the town of Cuyler. The doline occupies a pre-existing low that had also captured Beard Creek (Bing® 2012 image mounted and scaled in MapInfo).

on April 18, an adjacent mine room collapsed to form a second collapse crater (Figure 19). The initial March 12 collapse in the mine was accompanied by an inrush of brine and gas (methane) and by a sustained intense inflow of water at rates in excess of 70 m³/min, via the overlying now fractured limestone back or roof (Gowan and Trader, 2000).

In a little more than a month, the two steep-sided circular collapse features, some 100 meters apart, had indented the landscape above the two collapsed mine rooms (Figure 19). The northernmost collapse feature, which was more than 200 meters across, included a central area that was about 60 meters wide and had subsided about 6 to 10 meters. The southernmost feature, which was about 270 meters in diameter, included a central area that was about 200 meters wide and had subsided about 20 meters (Figure 19). Fractures extending up from the broken mine back created hydraulic connections between aquifers, which previously had been isolated from each and so provided new high volume flow routes for rapid migration of perched groundwaters into the mine level.

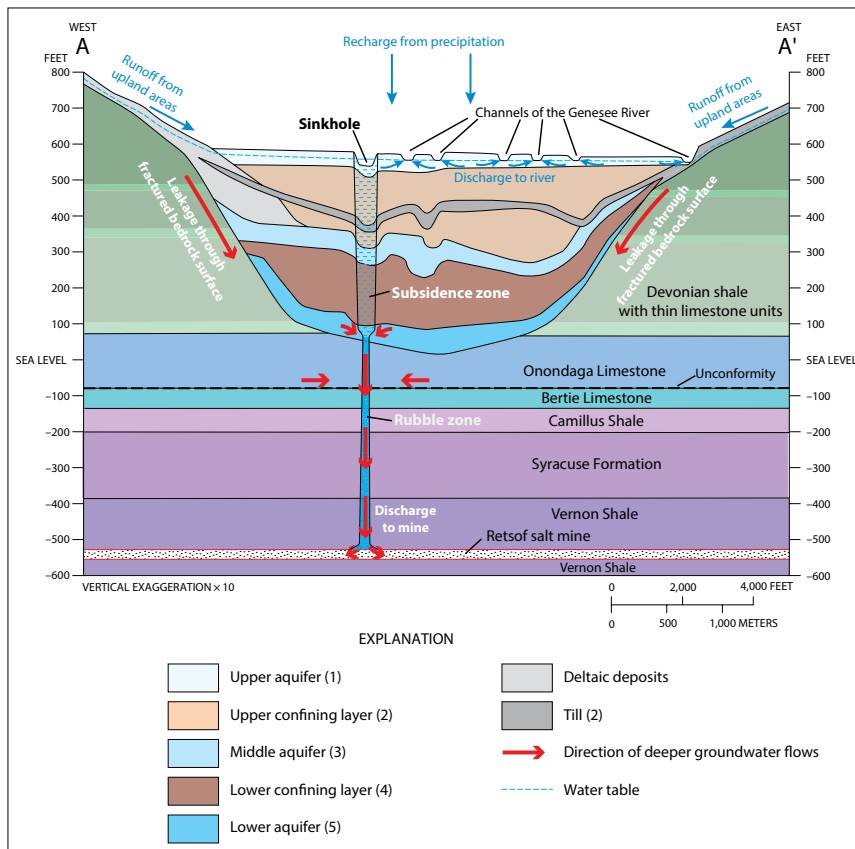
Figure 20. Stratigraphic section depicting rubble chimney above collapsed room in Retsof salt mine, Livingston County, N.Y. Also shown are the main aquifers that facilitated water influx into the flooding mine (inflow also drained natural and artificial brine-filled solution cavities in the stratigraphic levels above the working mine level (after Yager et al., 2009)

Water flooded the mine at rates that eventually exceeded 60,000 litres per minute and could not be controlled by pumping or in-mine grouting. By January 1996 the entire mine was flooded. Associated aquifer drawdown caused inadequate water supply to some local wells in the months following the collapse; the fall in the water table as ground waters drained into the mine in effect meant some water wells went dry (Figure 20; Tepper et al., 1997).
