**Re: Renewal of mining permit for Cayuga Salt Mine**

We are writing to express our view that the application to renew the Cayuga Salt Mine permit does *not* qualify as an application involving no changes to the original plans on which the existing permit is based.

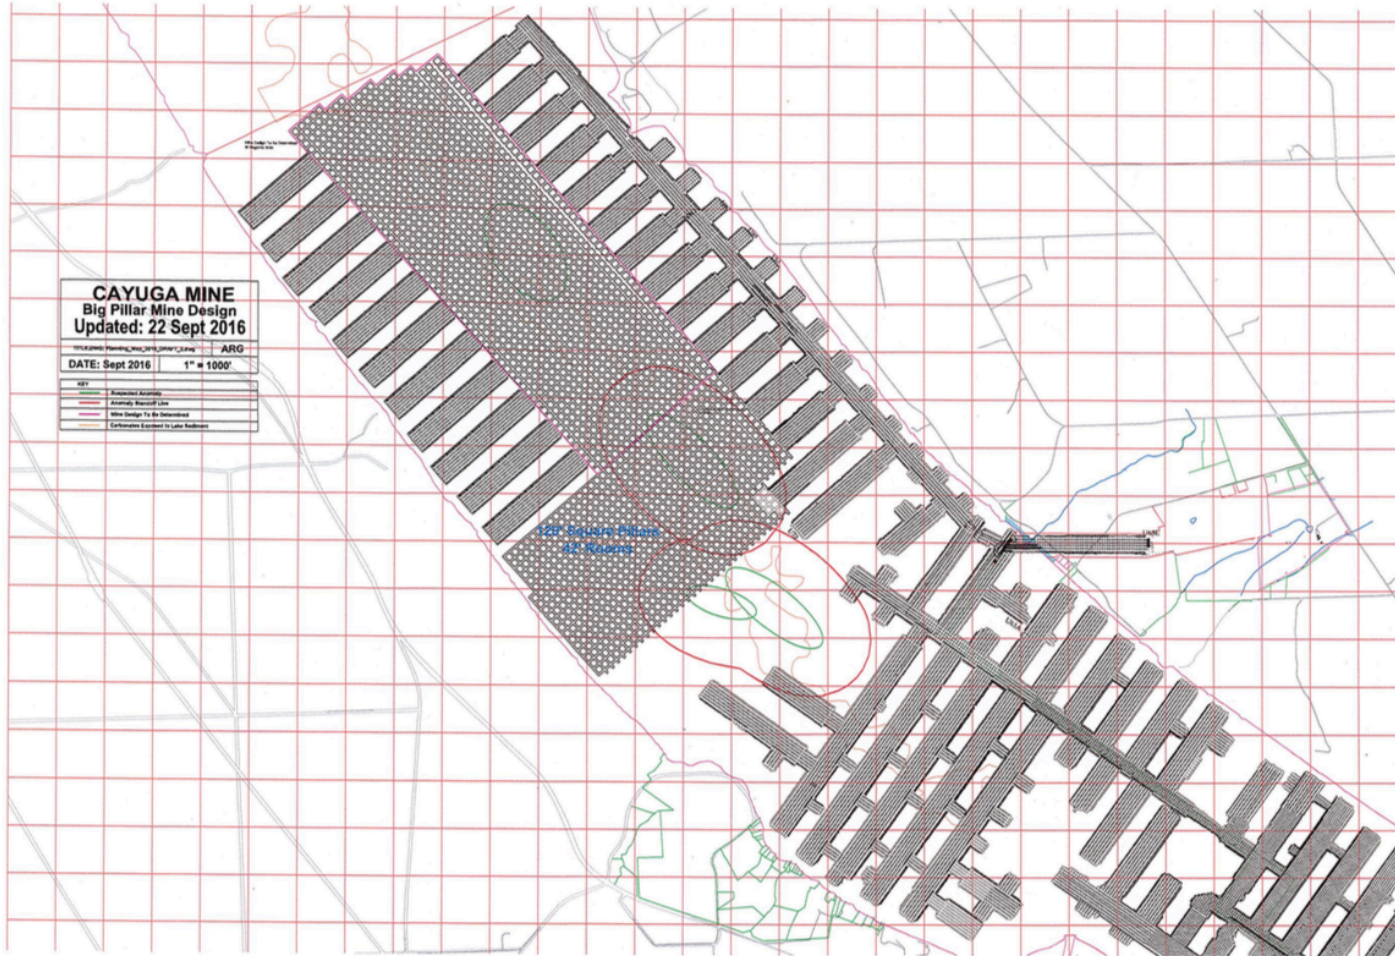
September 2016 Map:

Clearly shows anomalies (green ovals) with defined 1000 ft setbacks (red ovals); also shows “carbonates exposed to lake sediments” (difficult to see orange lines)

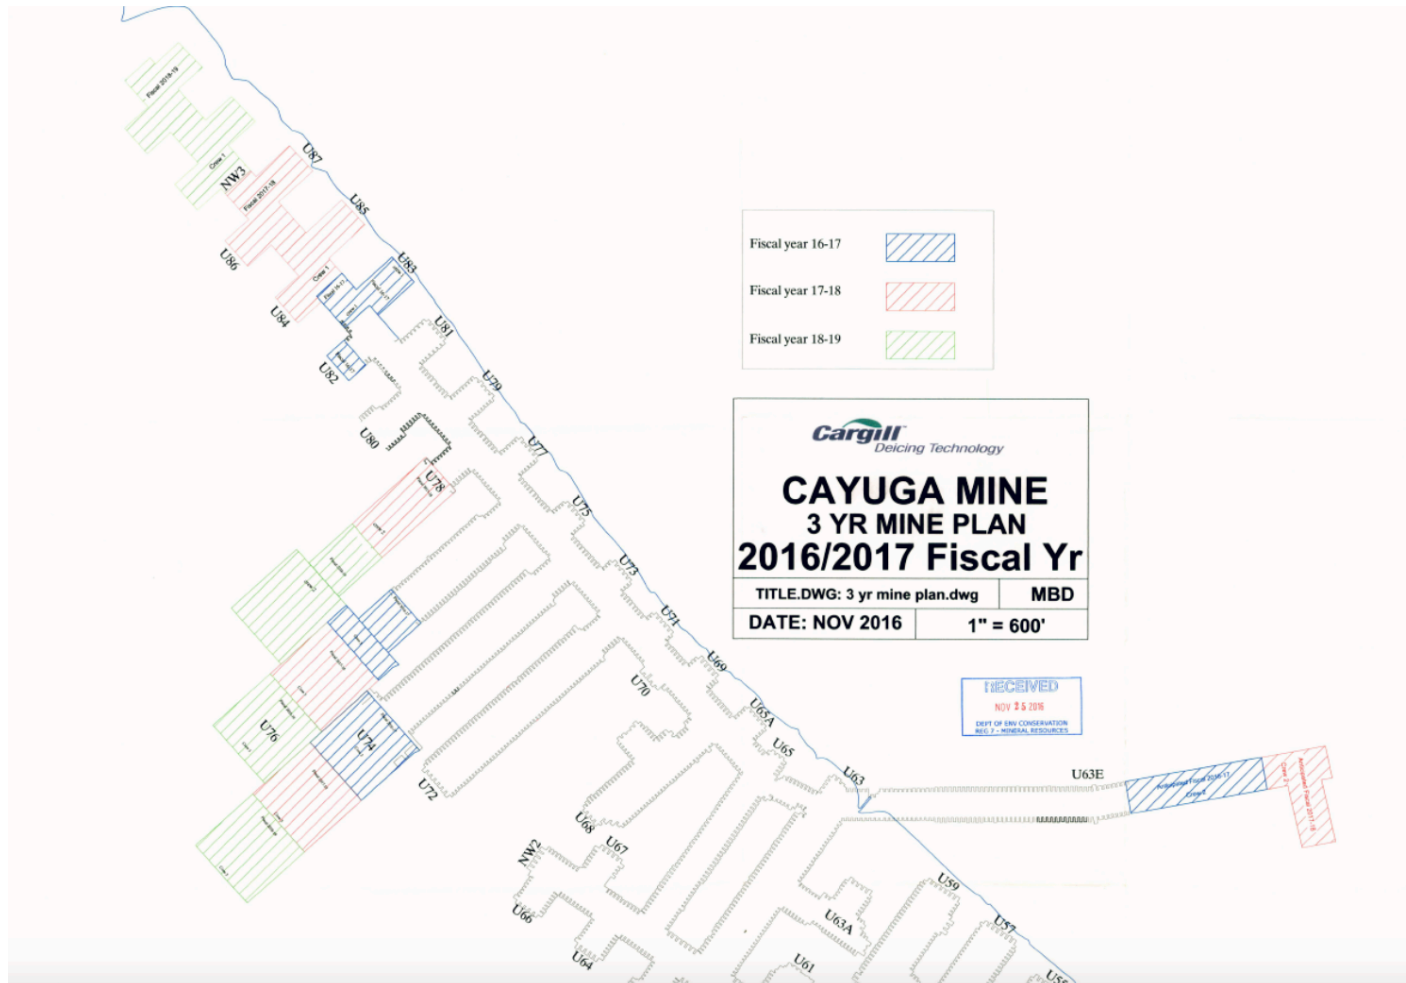
Attachment B

No mention of Frontenac Point Anomaly (FPA) and required setbacks

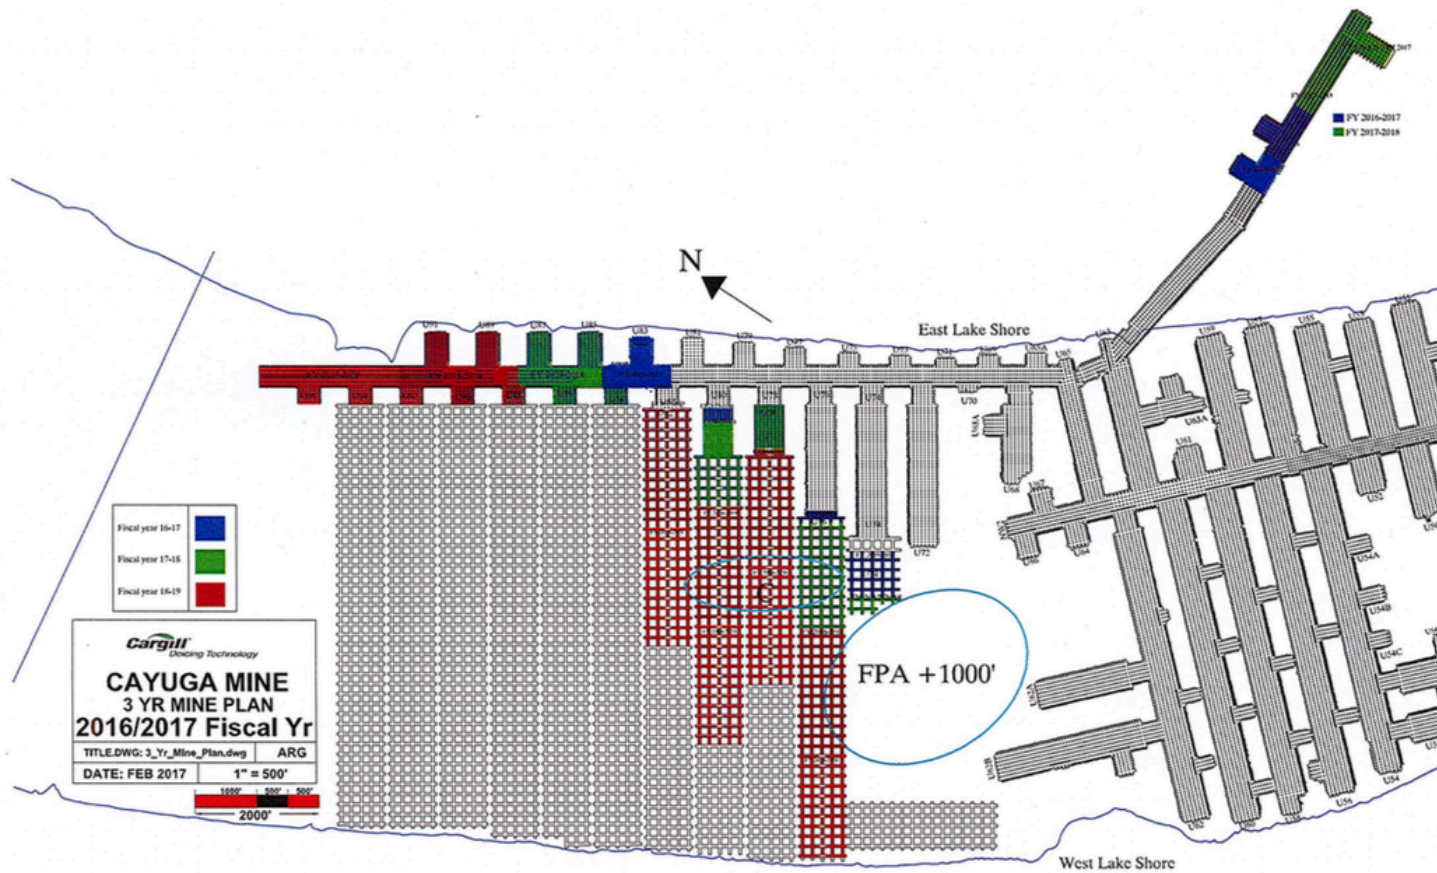
Attachment C:

FPA + 1000 ft setback is shown however the indicated area is now significantly smaller than the area indicated in the Sept 2016 map presented in Attachment A.

If mining setback presented in the September 2016 map had been observed then Planned (or completed mining) in Fiscal years 16-17 and 17-18 would be in violation of those setbacks.

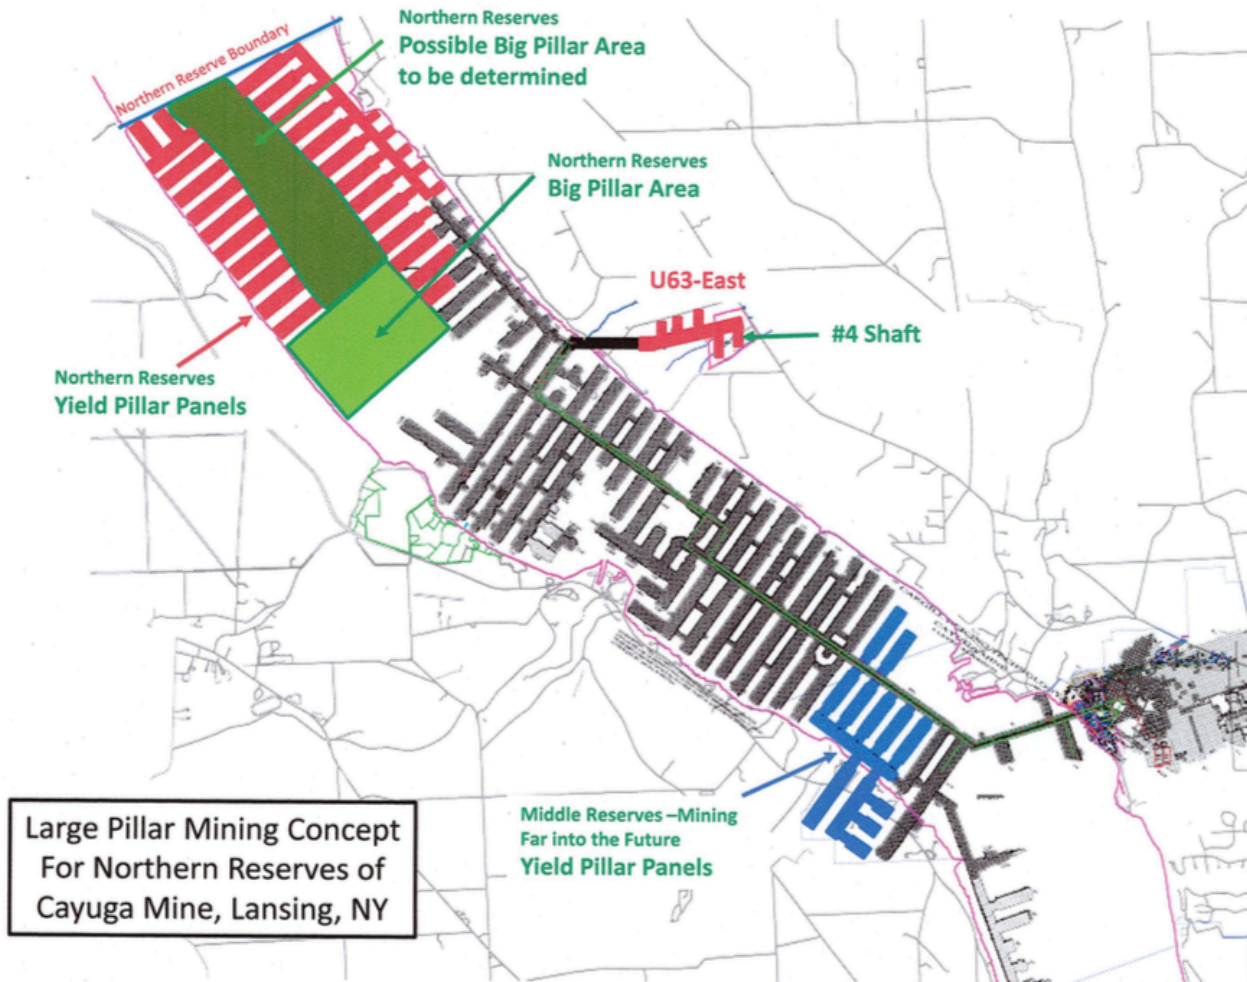
Attachment D:

No date (but likely Sept 2016 as it was included in a September 9, 2016 letter from David Plumeau to Steve Army). Large Pillar Mining Concept for Northern Reserves of Cayuga Mine, Lansing, NY

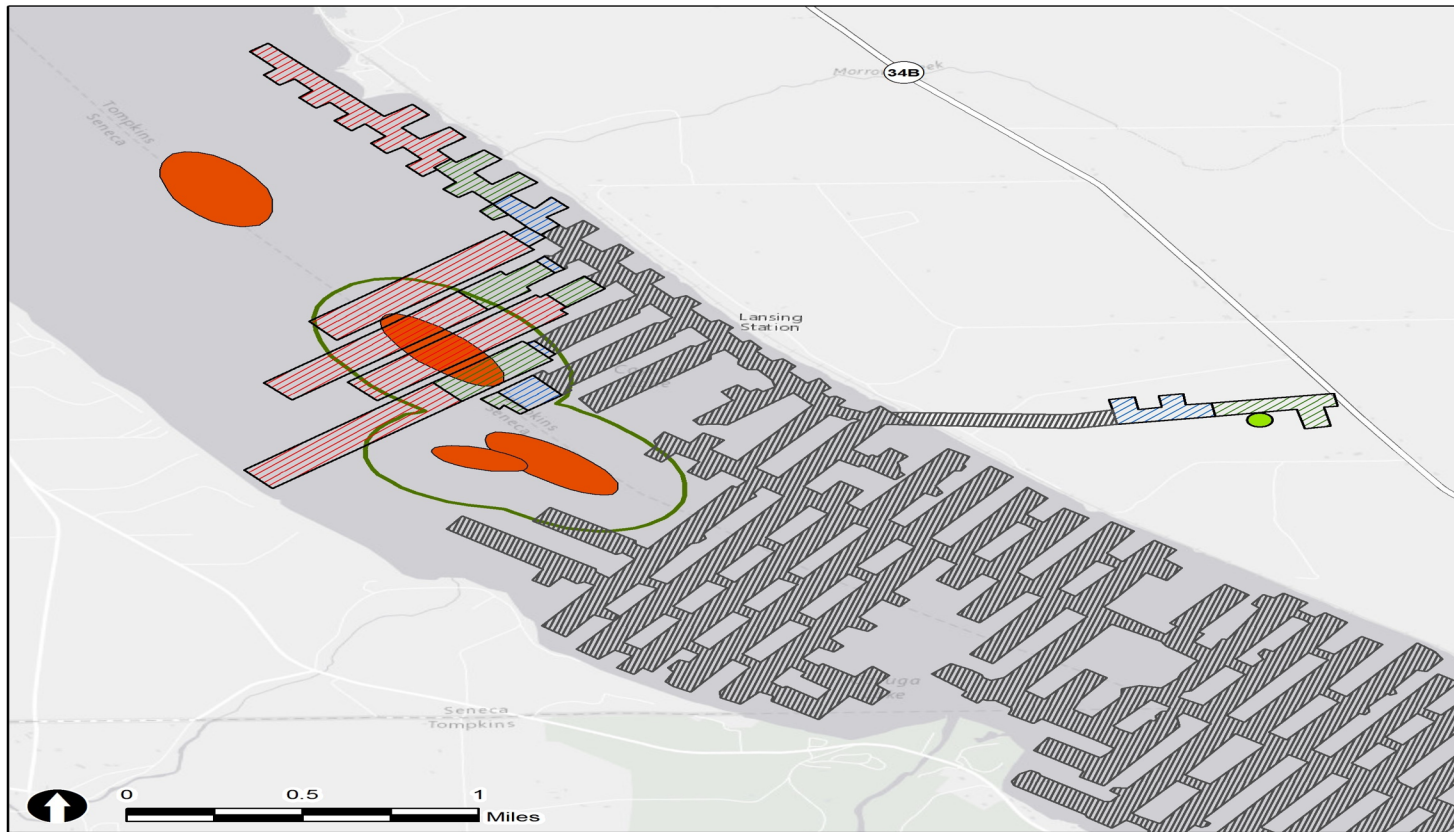
Attachment E: Overlay of 3 defined anomalies and associated setbacks with the 2017 mine map showing FY 16-17 and 17-18 mining.

Data: ESRI, NYS GIS Clearinghouse, "Cargill Mine Big Pillar Design: Updated September 22, 2016", "Cargill Mine, 3 Yr Plan: 2016/2017 Fiscal Year".  
Map updated: 9 October 2017

Our cartographer has produced a clearer map of "suspected anomalies" and associated setbacks as shown in Attachment E. The issue of whether DEC-mandated setbacks are binding requirements associated with Cargill's compliance with its mining permit or "recommendations" that Cargill is free to ignore is another example of an issue that needs detailed review.
