Annual Reporting, Monitoring, and Notifications

12.a.(1) - Cargill Cayuga Mine Manager Certification:

12.a.(3) - 3 Year Mining Plan

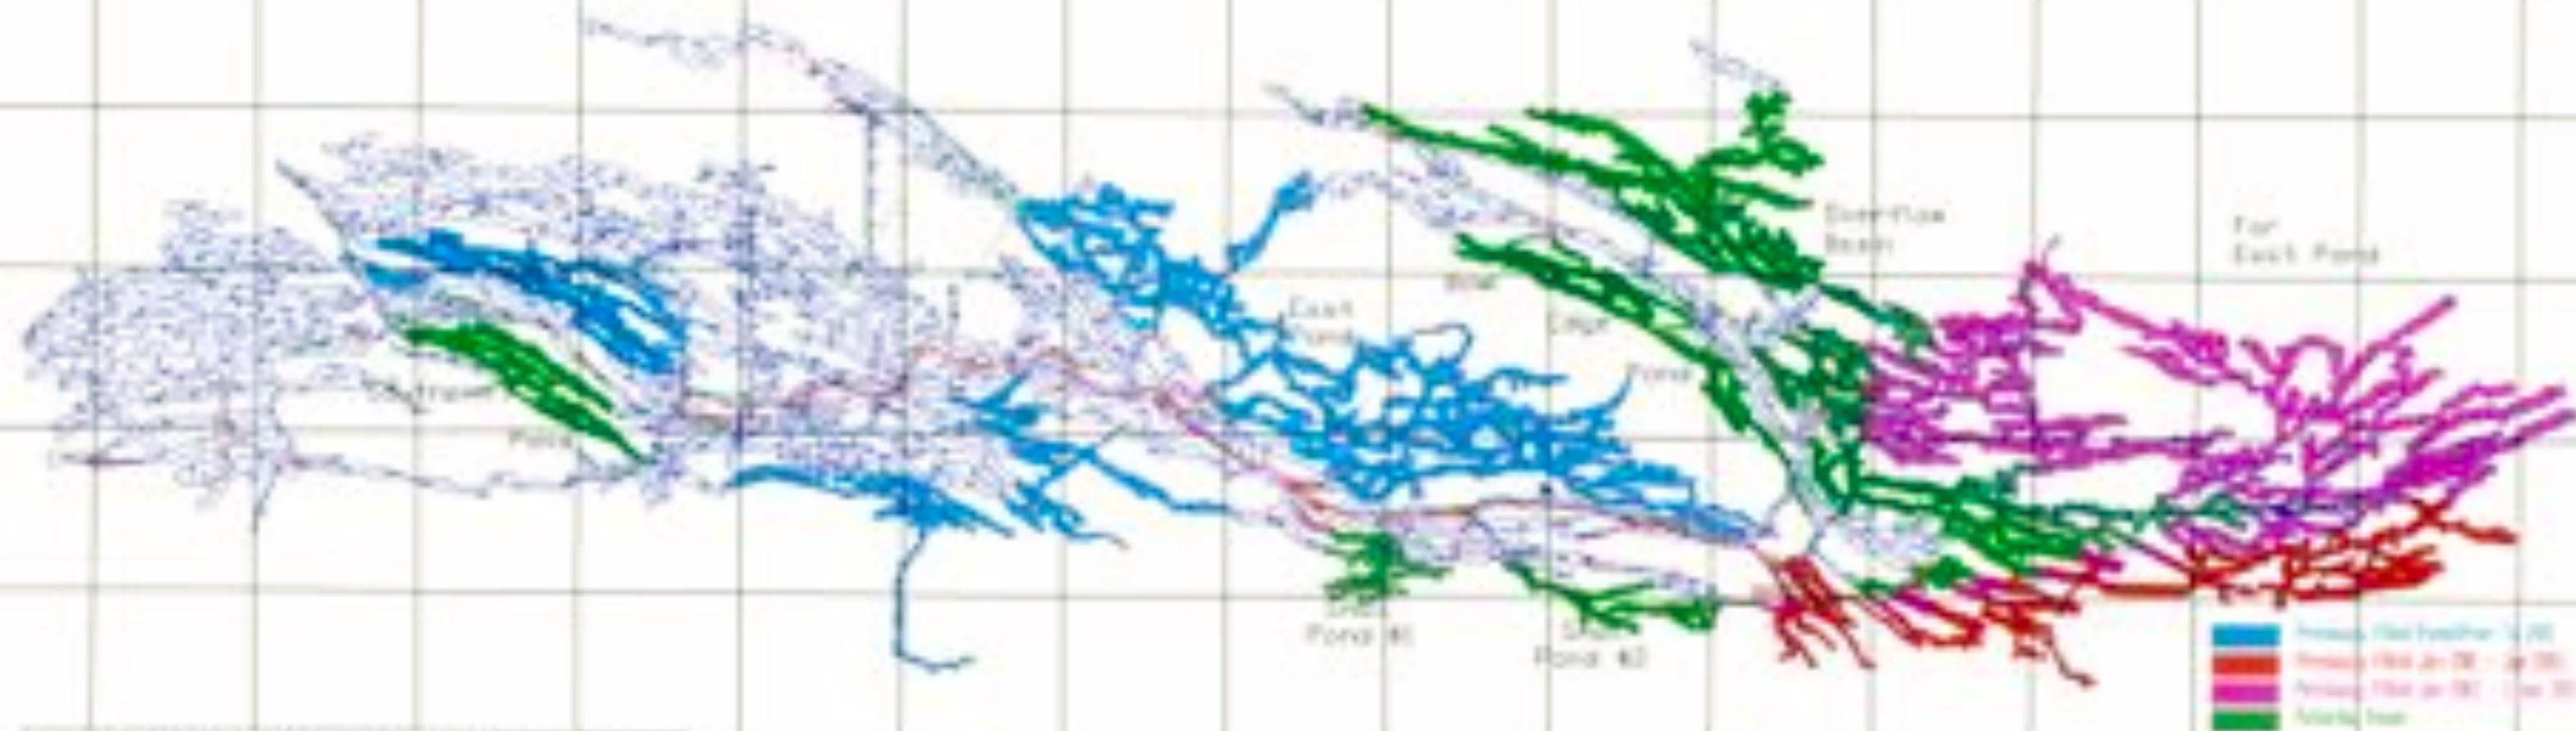
CAYUGA MINE
4 Level Pond Map
Updated: 18 Nov 2014

TITLE.DWG: 4 Level Pond Map.dwg MDC

1" = 600'

Grid spacing = 1000 ft.
