SELECTED ASPECTS of FINGER LAKES GEOLOGY

**The Unappreciated Horizontal Stress Field
and
Topographic (Valley) Issues**

**R.A. YOUNG
GEOLOGICAL SCIENCES
SUNY, GENESEO
June 2017**

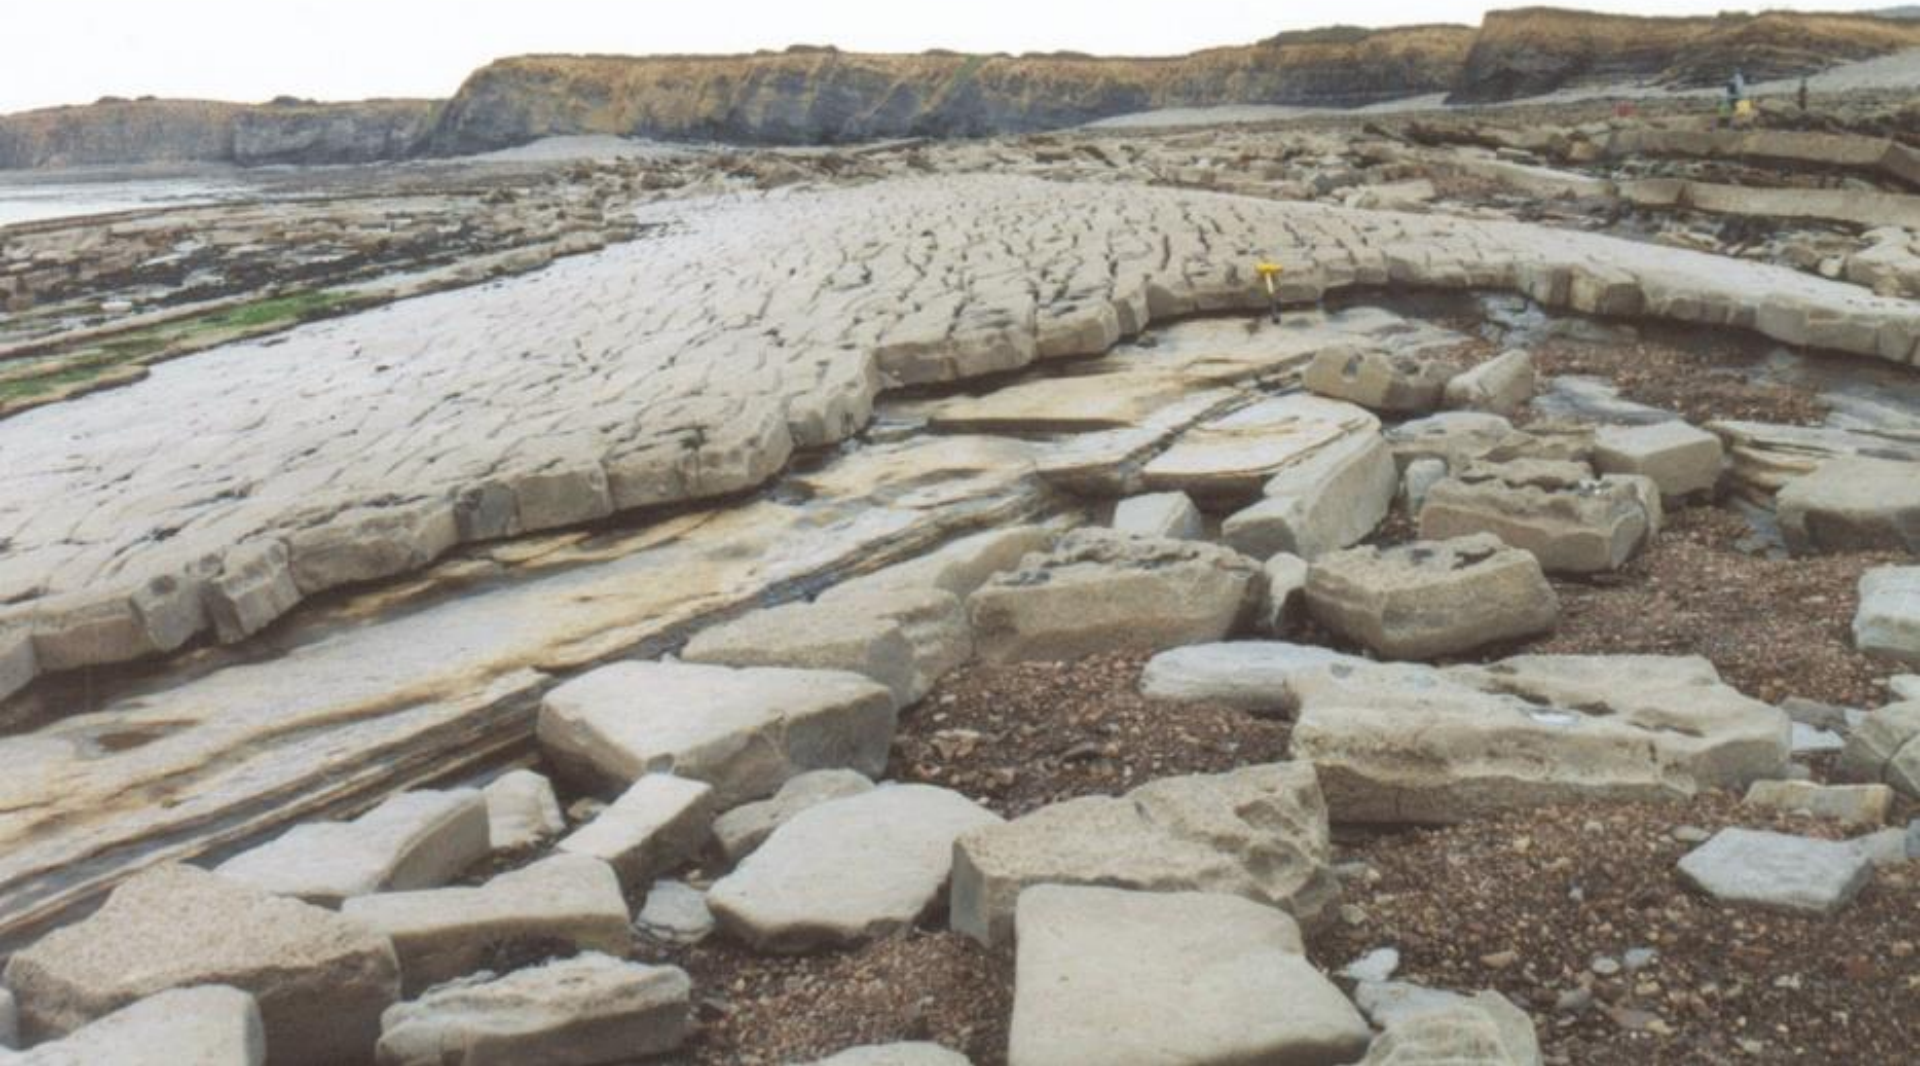
Fractures At Crest of Anticline

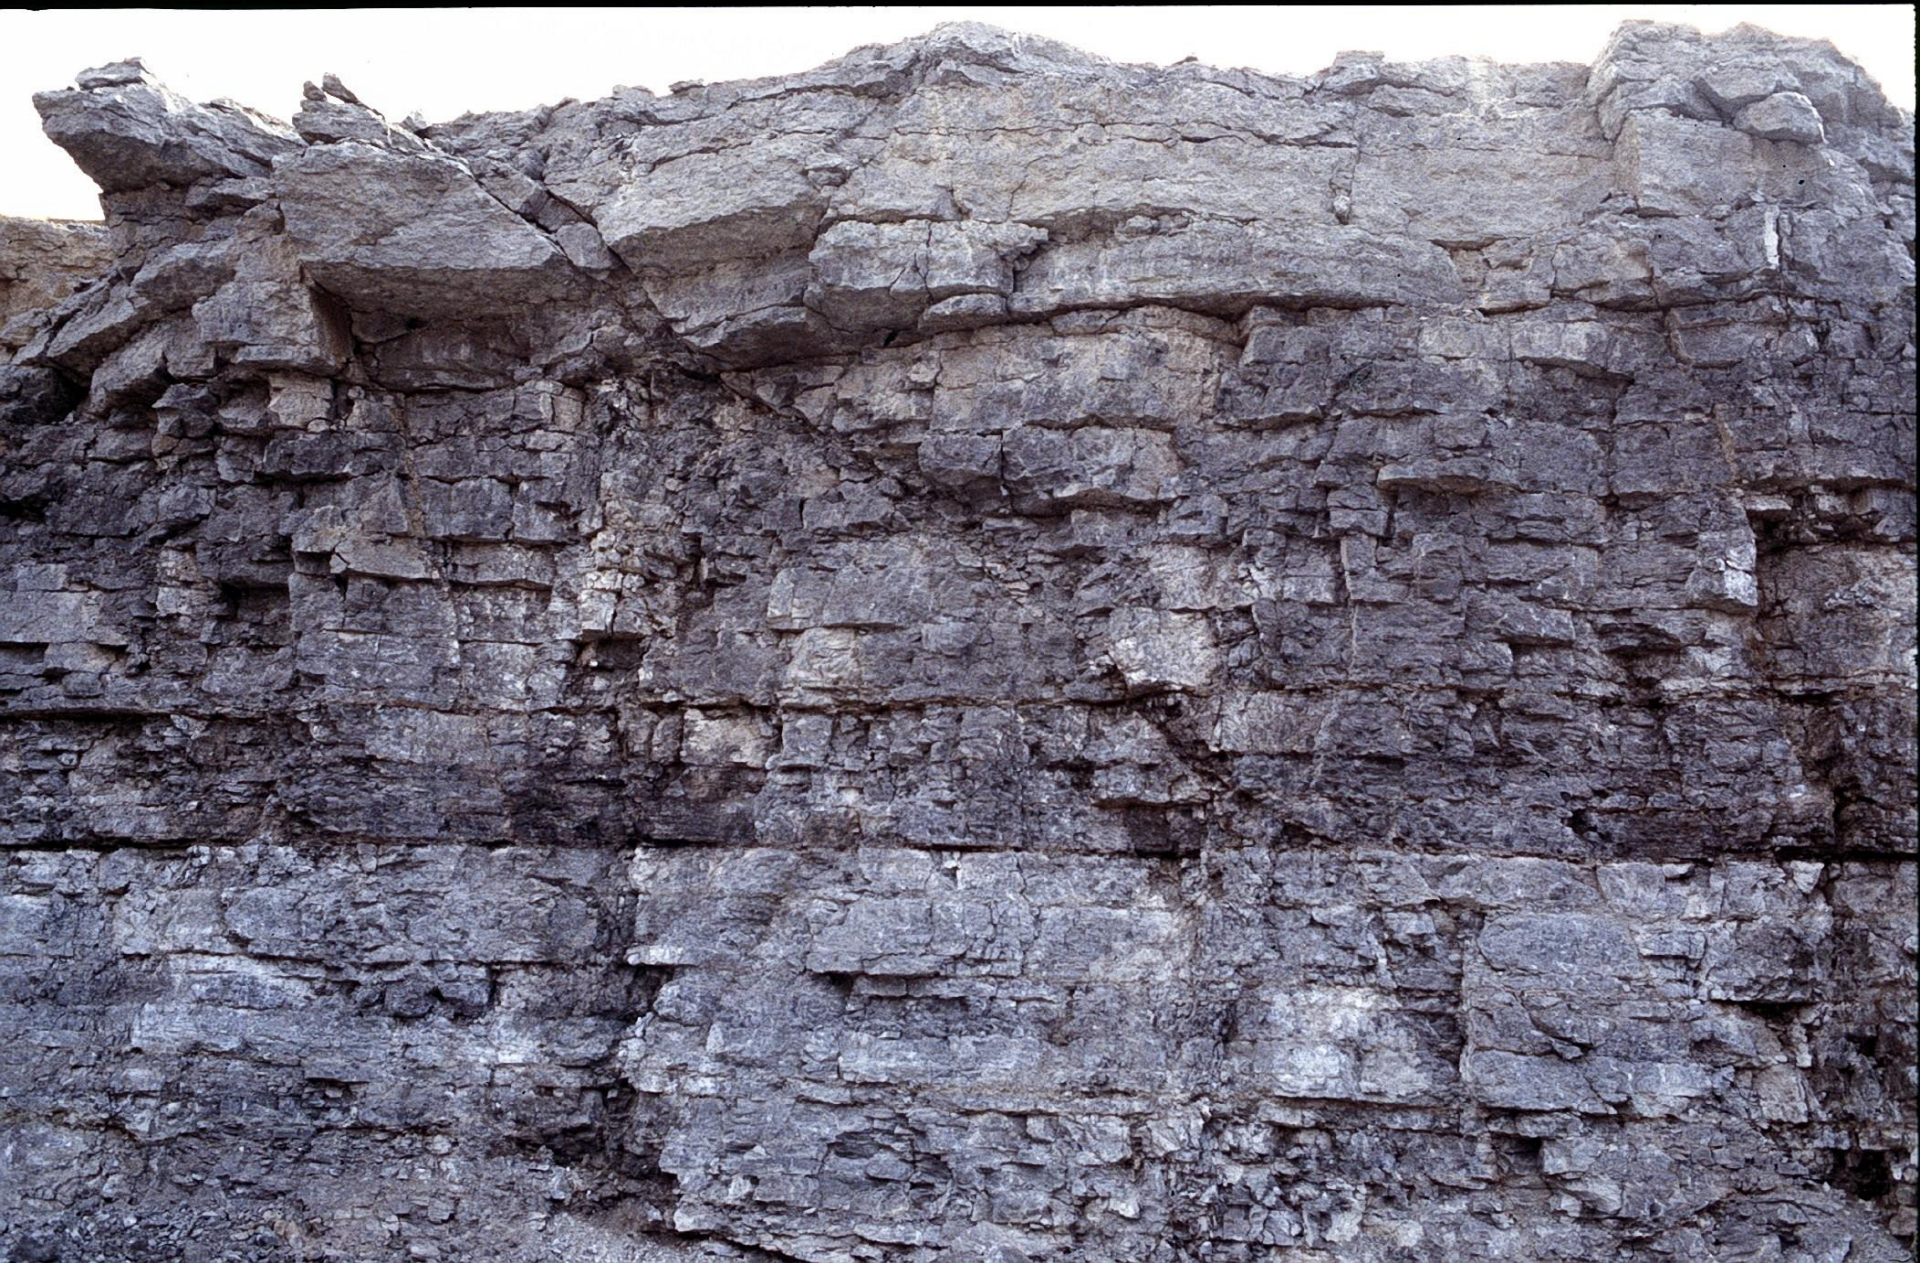
Not all master joints or joint sets are vertical

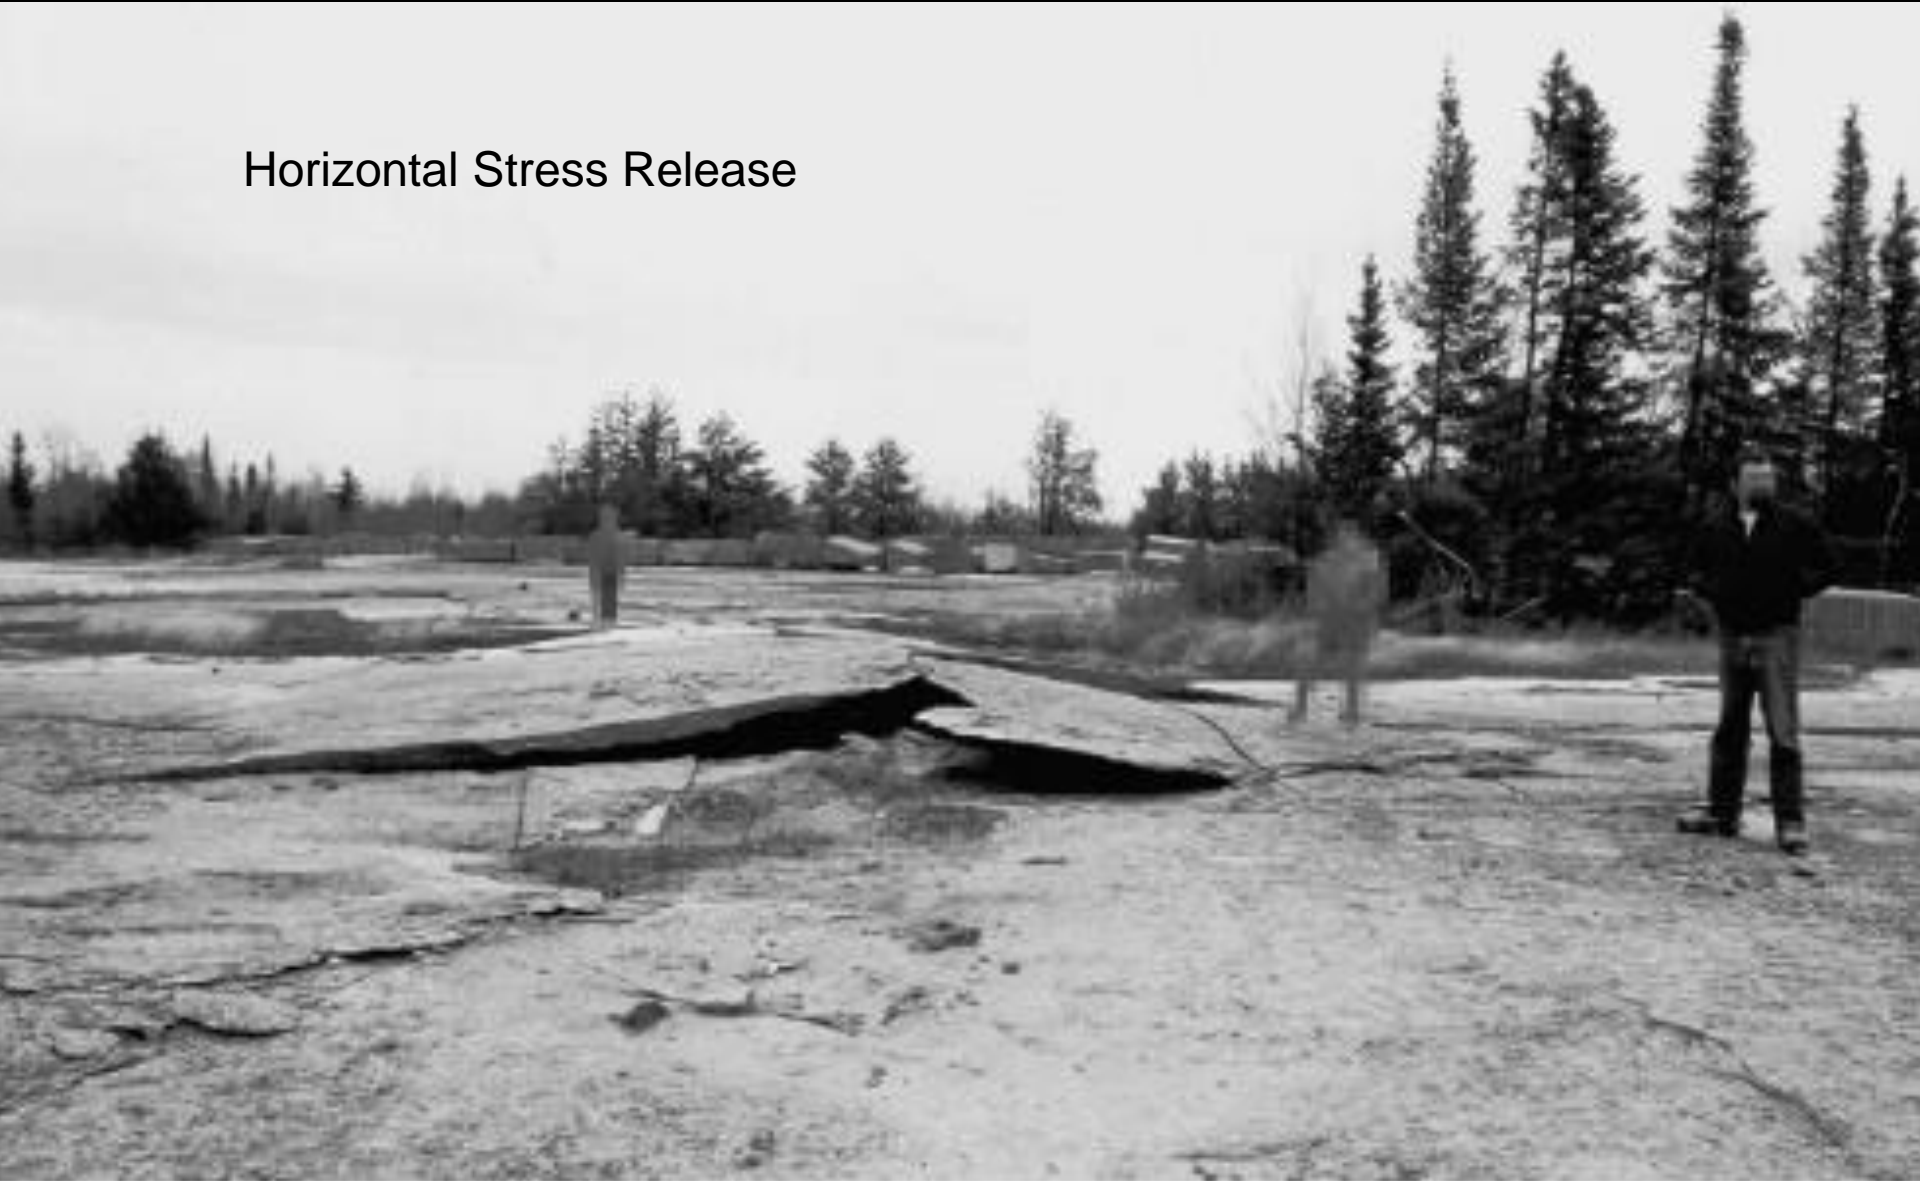
Horizontal Stress Release

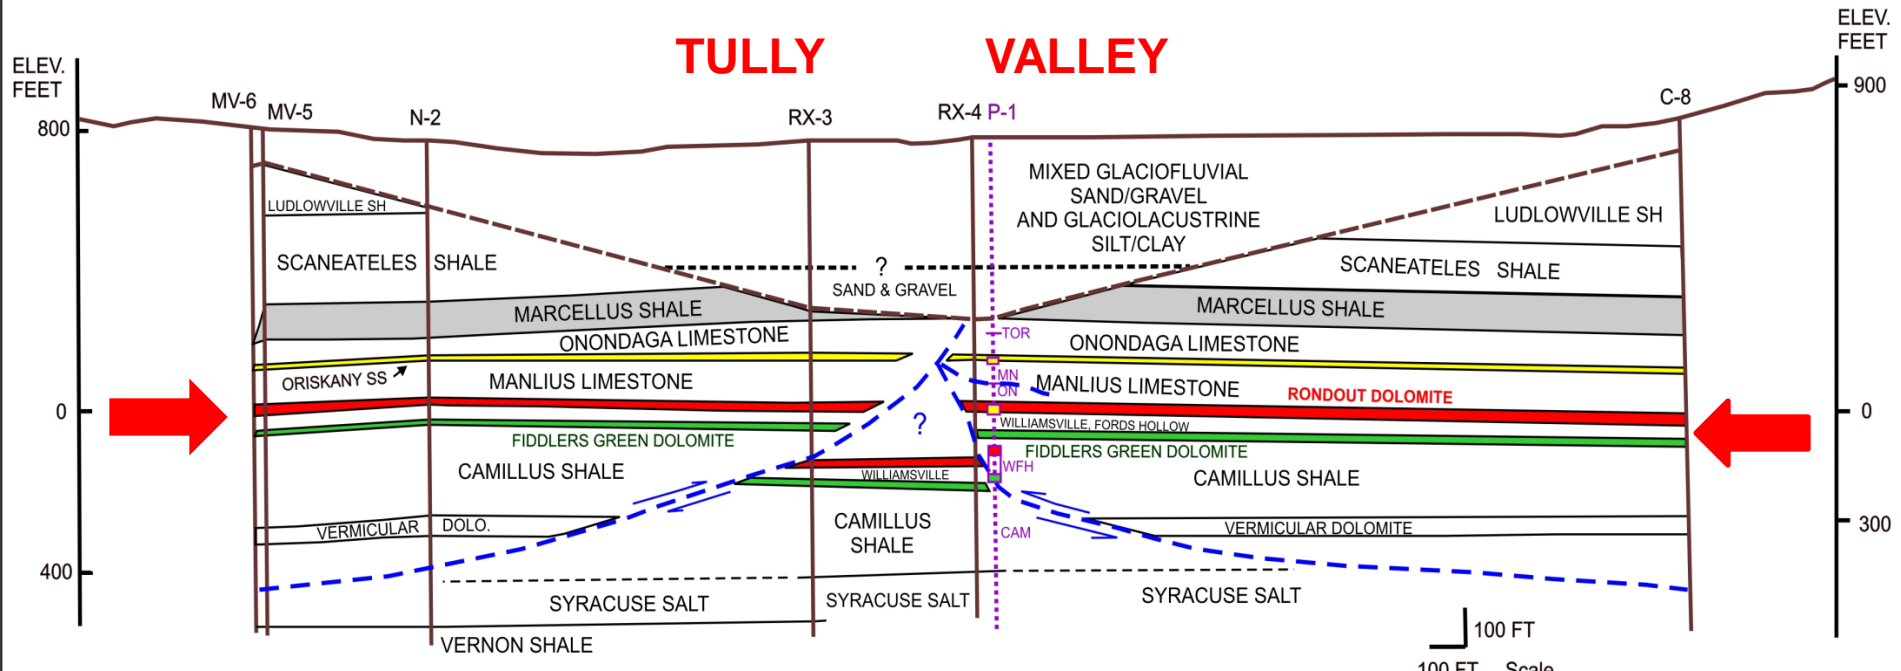
TULLY VALLEY CROSS SECTION SLIGHTLY SIMPLIFIED FROM H&A FIGURE 4, FEBRUARY 1992, File No. 70259-00
 COLORS ADDED FOR CLARITY, FAULT SOLUTION MODIFIED WHERE GEOLOGY UNCERTAIN
 SCALE CONVERTED TO 1:1 and GROUNDWATER INFORMATION OMITTED

Well P-1 is only 120 feet northeast of RX-4 but slightly offline from main section, so formation contacts are lower and repeated reflecting structural complexity. Note especially repetition of beds in Onondaga, Oriskany, Manlius sections in P-1. Thrust relationships are complex and difficult to diagram accurately at P-1. TOR = Top of Rock
