*Cargill Salt – Road Safety
P.O. Box B
Lansing, NY 14882*

RE: Annual Report for Mine File #709-3-29-0052; Cayuga Salt Mine
Permit ID#0-9999-00075-00001
Towns of Lansing and Ulysses, County of Tompkins
Town of Covert, County of Seneca

Annual Reporting, Monitoring, and Notifications

CAYUGA MINE 3 YR MINE PLAN	
DRAFTED BY:	MBD
DATE: 1/19/2021	
SCALE:

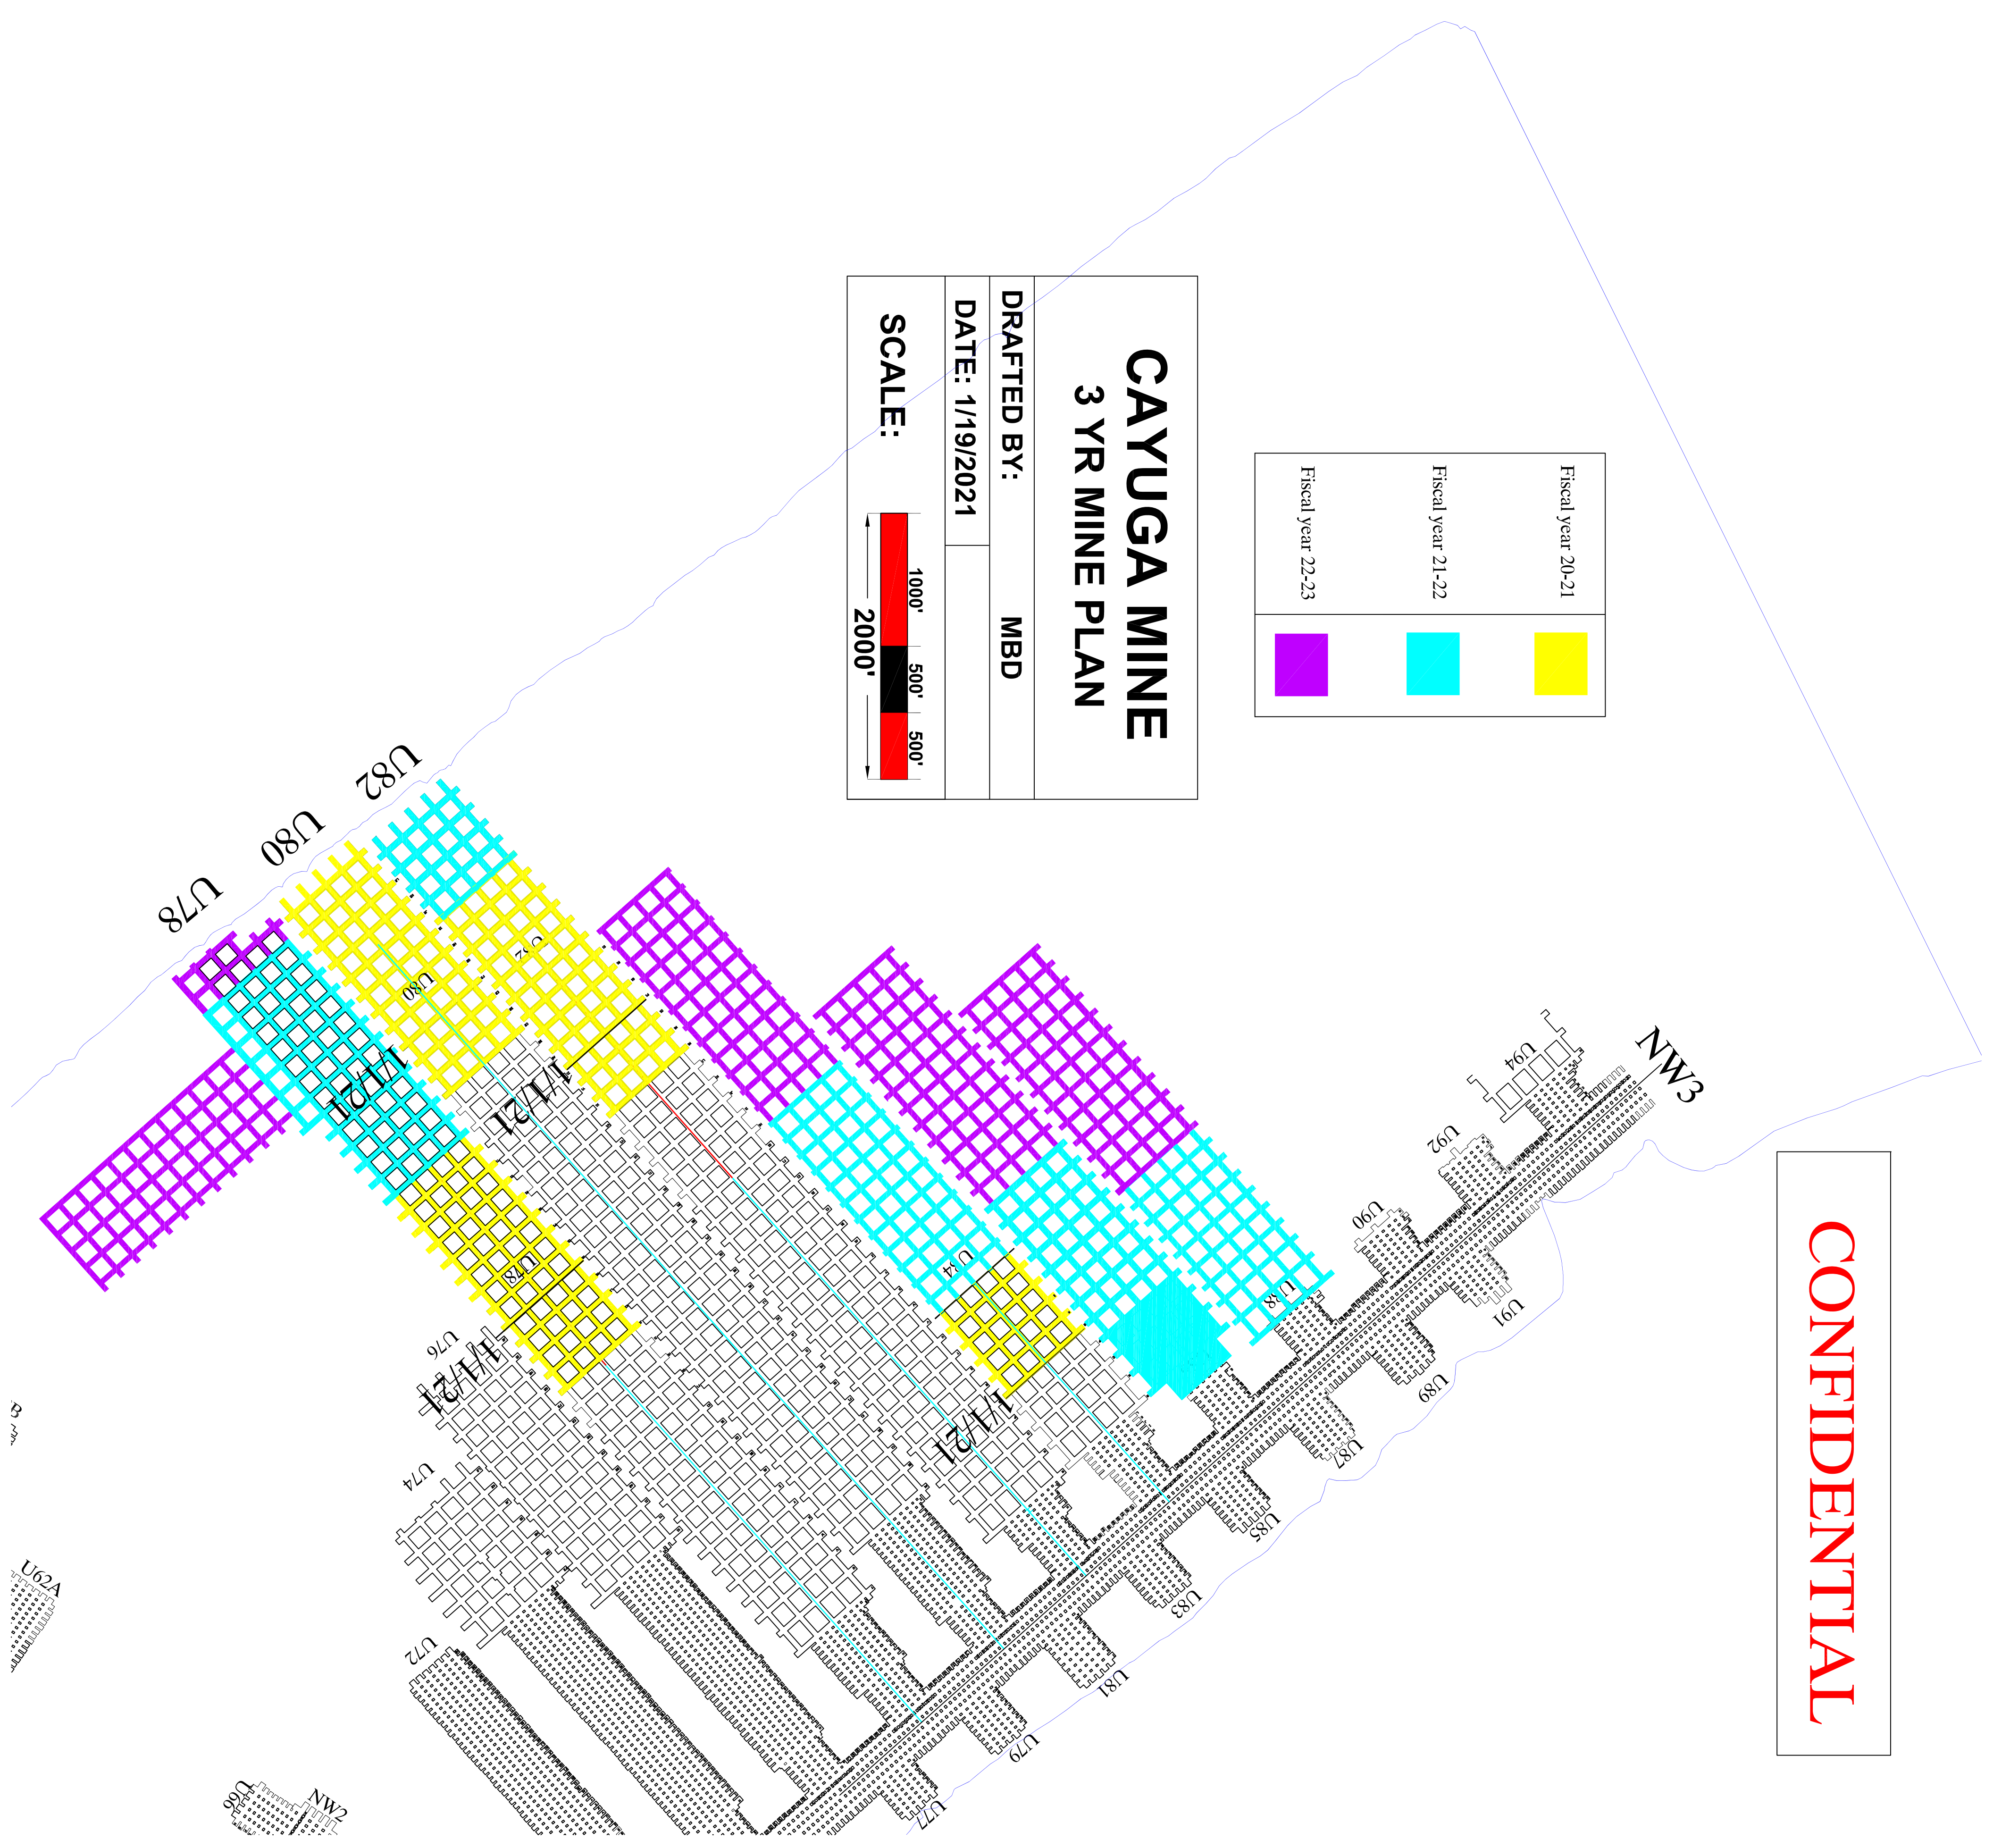
A map is attached depicting the current and proposed mining for the next three years.

The Cayuga Mine is currently operating in the northern region of the mine. Active mining is located in panels U-78, U-80, U-82 U-84, and NW-3.
